ZIERKE SOIL TESTING

Compliance inspection report form

Existing Subsurface Sewage Treatment System (SSTS)

Brief system description: (2) 1000 gallon septic tanks, 1000 gallon lift station, drop box rock trench drainfield

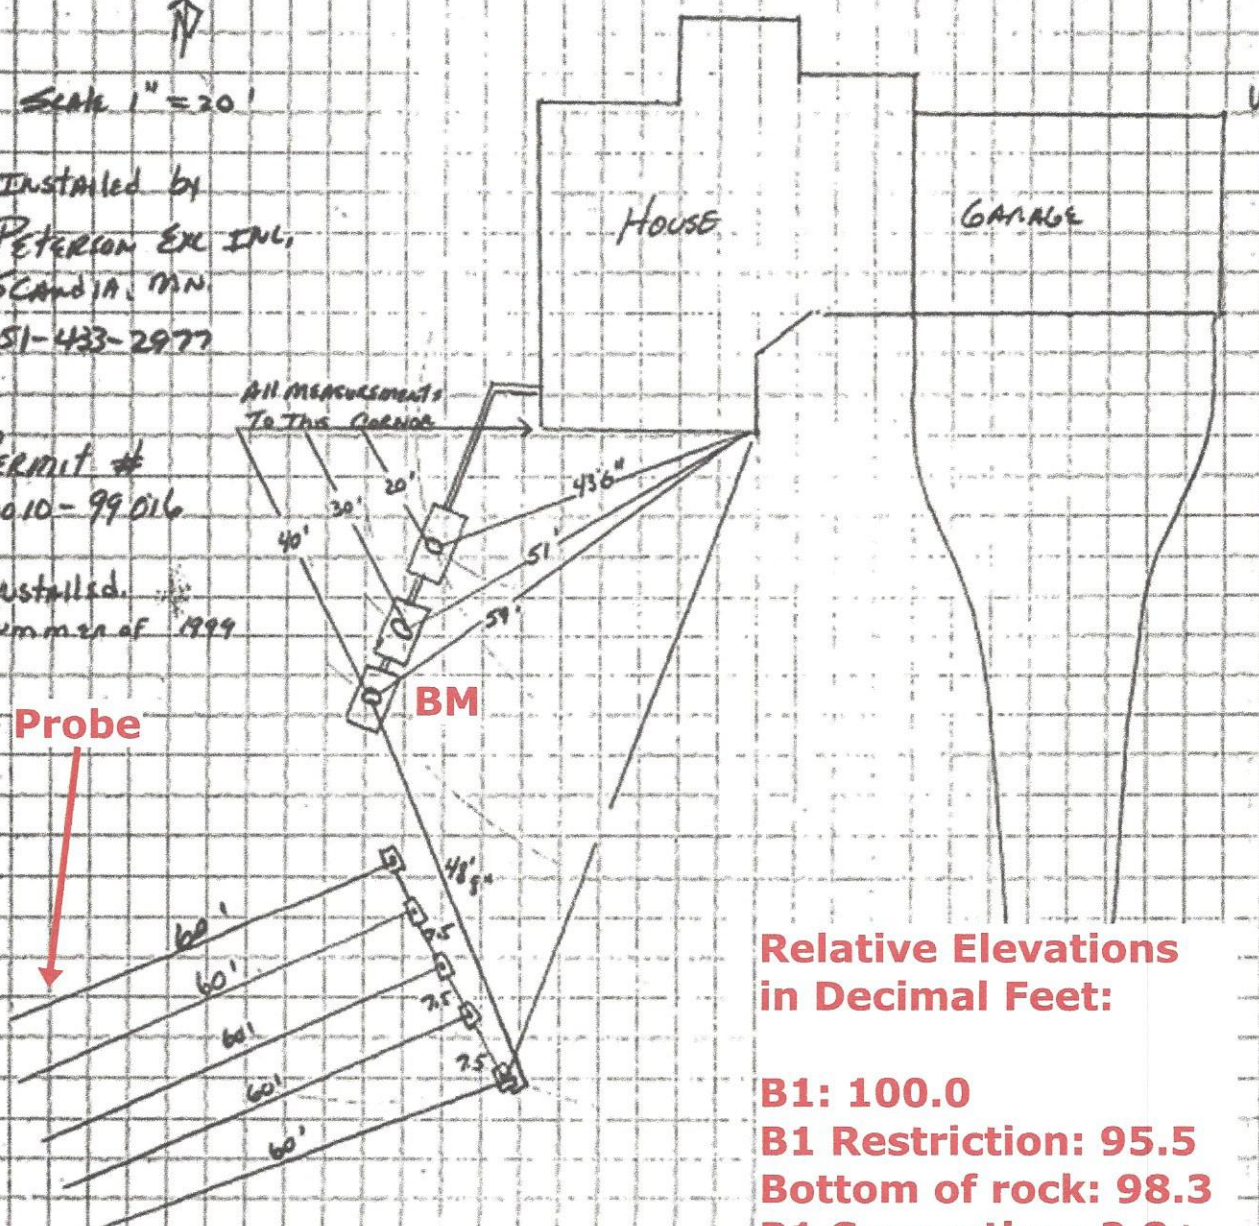
**Inspection notes from
9/22/2021 site visit
in RED**

Probe

B1

**Relative Elevations
in Decimal Feet:**

- B1: 100.0**
- B1 Restriction: 95.5**
- Bottom of rock: 98.3**
- B1 Separation: 2.8+**
- Benchmark: 99.4**
(cover on lift station)
