| P.O. Box 10853 White Bear La | Brian Humpal | | | | | |
|--|---|--|--|--|--|--|
| SUBSURFACE SEWAGE TREATMENT SYSTEM (SSTS) COMPLIANCE REPORT | | | | | | |
| Date: November 16, 2022Time: 9:45 AMOwner: Darcel Diedrich | | | | | | |
| Inspection Address: 8239 Deer Pond Ct N, Lake Elmo, MN 55042 | | | | | | |

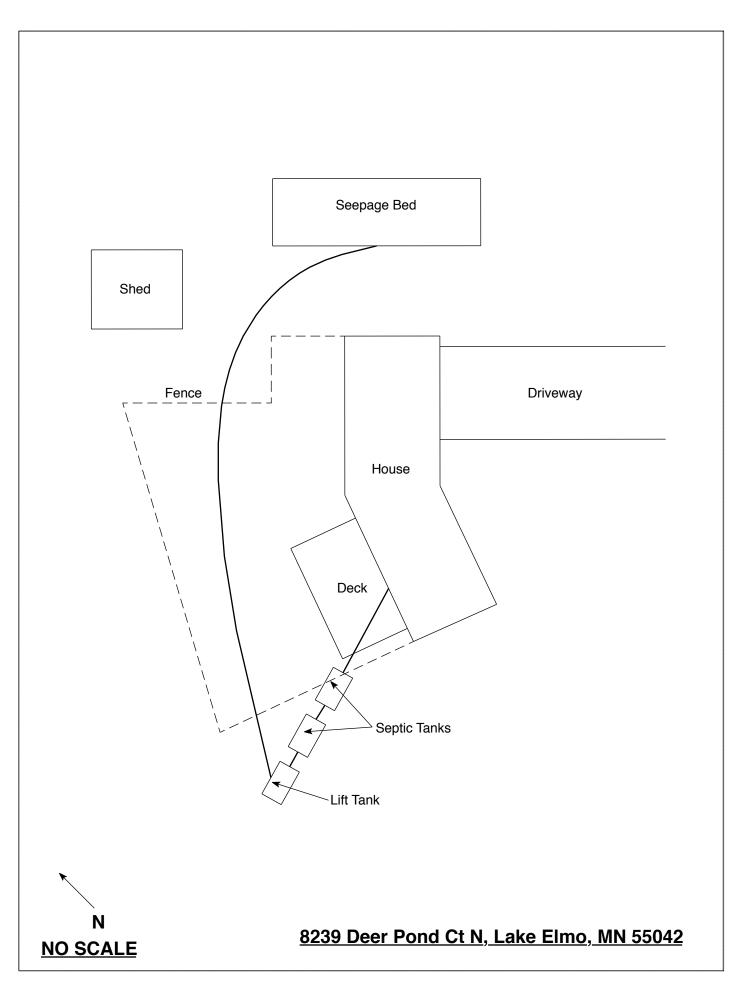
| DATE// | - 20- 00 | | NDY NO FROST | 1 | BOREHOLE DIAMETER 4"- | -3%" HAND AUGE |
| DEPTH FEET | HOLE #1 | HOLE #2 | HOLE #3 | HOLE #4 | HOLE #5 | CLASSIFICAT |
