Property address: 2570 OVERLOOK CT N, STILLWATER

Brief system description: SEPTIC TANK AND GRAVITY DRAINFIELD INSTALLED 1992

System status on date (mm/dd/yyyy): 1/10/2022

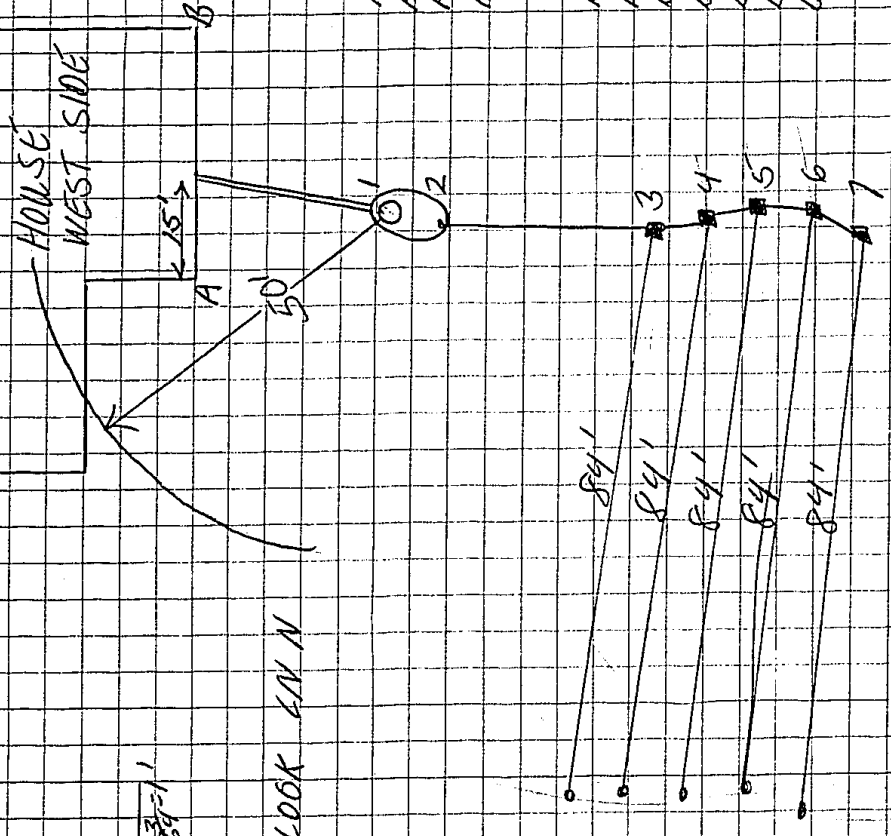
2570 OVERLOOK LN N

GARAGE

WELL

HOUSE WEST SIDE

NORTH
SCALE 1/8" = 1'

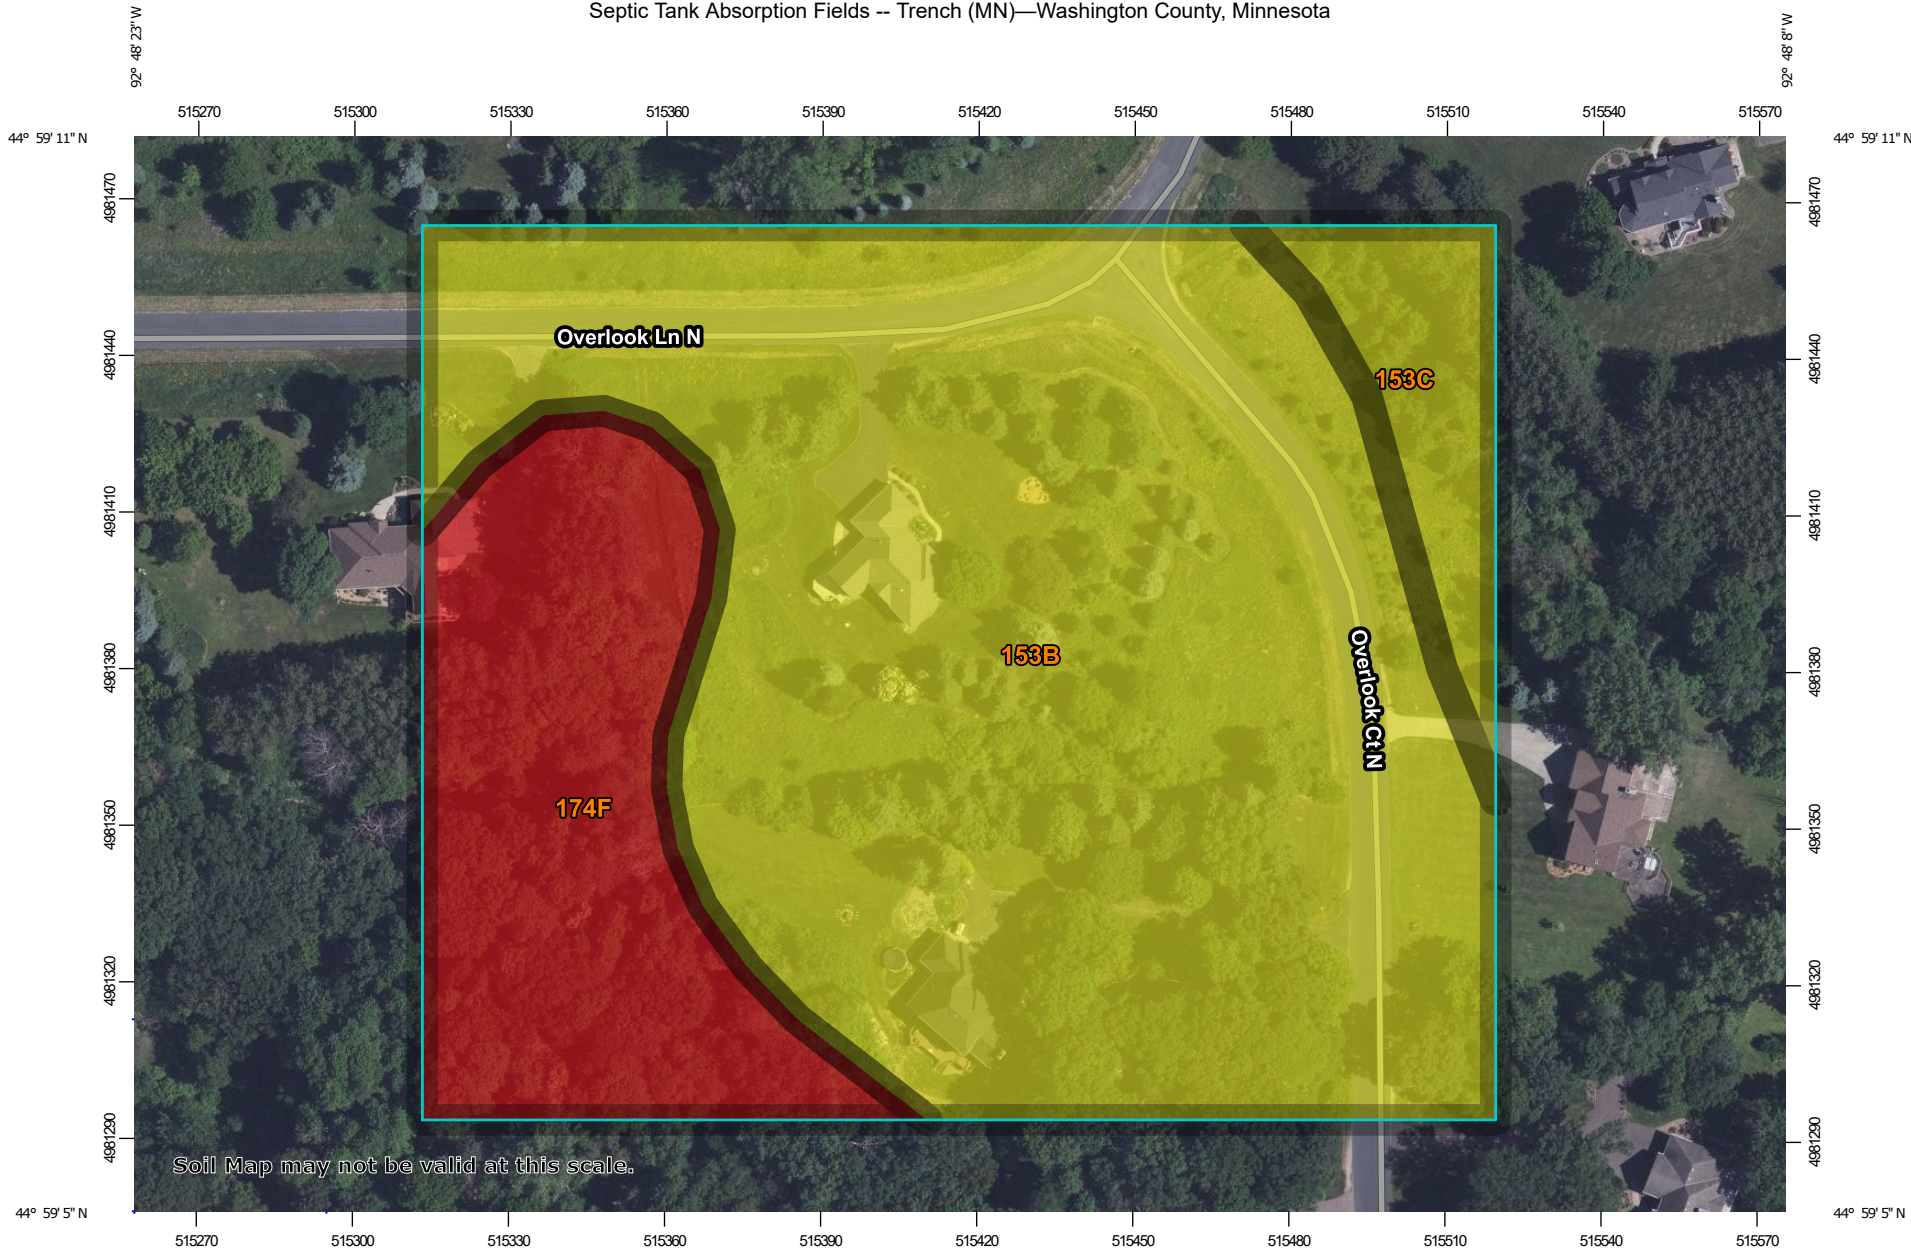
Septic Tank Absorption Fields -- Trench (MN)—Washington County, Minnesota

Map unit symbol	Map unit name	Rating	Component name (percent)	Rating reasons (numeric values)	Acres in AOI	Percent of AOI
153B	Santiago silt loam, 2 to 6 percent slopes	Moderately limited	Santiago (90%)	Restricted percolation (0.30)	6.3	72.4%
153C	Santiago silt loam, 6 to 15 percent slopes	Moderately limited	Santiago (90%)	Restricted percolation (0.30)	0.5	6.2%
				Slope (0.05)		
174F	Gale silt loam, 25 to 50 percent slopes	Extremely limited	Gale (90%)	Depth to bedrock (1.00)	1.9	21.4%
				Slope (1.00)		
				Restricted percolation (0.30)		
Totals for Area of Interest					8.8	100.0%

Rating	Acres in AOI	Percent of AOI
Moderately limited	6.9	78.6%
Extremely limited	1.9	21.4%
Totals for Area of Interest	8.8	100.0%
