ZIERKE SOIL TESTING

Compliance inspection report form

Existing Subsurface Sewage Treatment System (SSTS)

Property information	Local tracking number:		
Parcel ID# or Sec/Twp/Range: 0103220130001	Reason for Inspection Sale		
Local regulatory authority info: Washington County			
Property address: 23723 Pomroy Ave N Scandia, MN 55073			
Owner/representative: Linda Hiltner	Owner's phone: NA		
Brief system description: Round pre-cast septic tank with gravity	y rock trench drainfield		
System status			
System status on date (mm/dd/yyyy): 3/23/2023			
☐ Compliant – Certificate of compliance*	☐ Noncompliant – Notice of noncompliance		
(Valid for 3 years from report date unless evidence of an imminent threat to public health or safety requiring removal and	Systems failing to protect ground water must be upgraded, replaced, or use discontinued within the time required by local ordinance.		
abatement under section 145A.04, subdivision 8 is discovered or a shorter time frame exists in Local Ordinance.) *Note: Compliance indicates conformance with Minn. R. 7080.1500 as of system status date above and does not	An imminent threat to public health and safety (ITPHS) must be upgraded, replaced, o

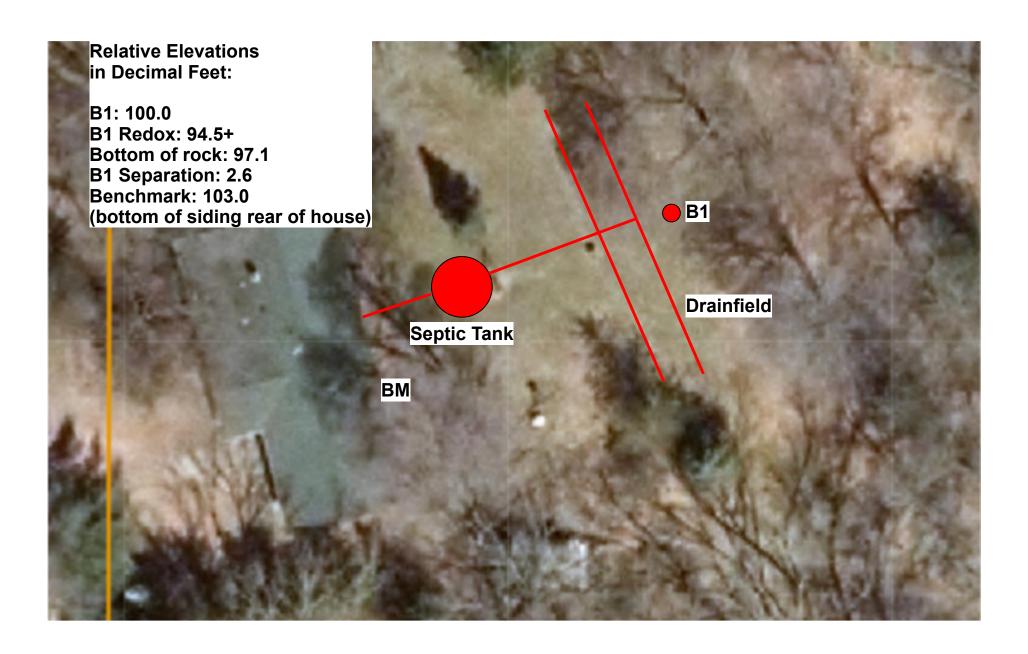
nd	A. Bottom of distribution media	97.1'				
	3	B. Periodically saturated soil/bedrock	94.5'				
		C. System separation	2.6'				
		D. Required compliance separation*	2.0'				
		*May be reduced up to 15 percent if all Ordinance.	owed by Local				
5c. "Experimental", "Other", or "Performance' systems built under pre-2008 Rules; Type IV or V systems built under 2008 Rules 7080. 2350 or 7080.2400 (Intermediate Inspector License required 2,500 gallons per day; Advanced Inspector License required > 2,500 gallons per day)	≤ or						
Drainfield meets the designed vertical separation distance from periodically saturated soil or bedrock.

Soil borings and elevations recorded. See sketch.
