Midwest Sewer Services

SUBSURFACE SEWAGE TREATMENT SYSTEM (SSTS) COMPLIANCE REPORT

Date: June 12, 2023

Inspection Address: 15123 Afton Hills Dr S, Afton, MN 55001

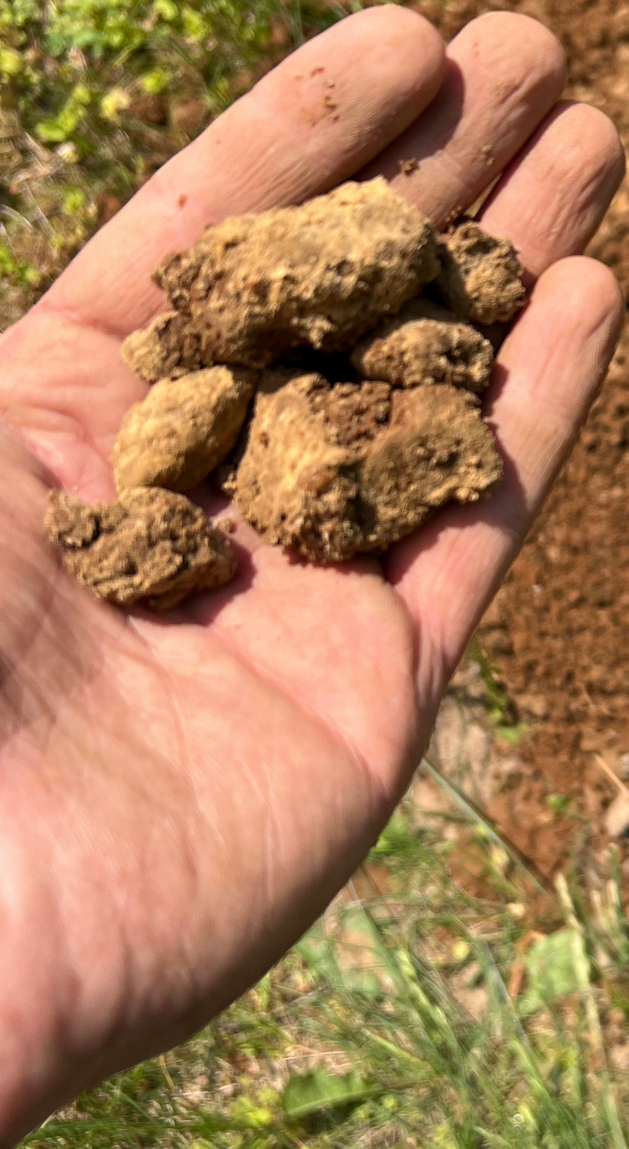
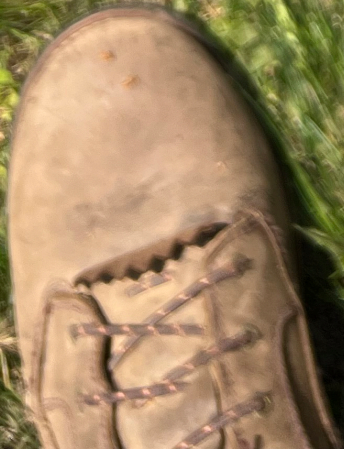
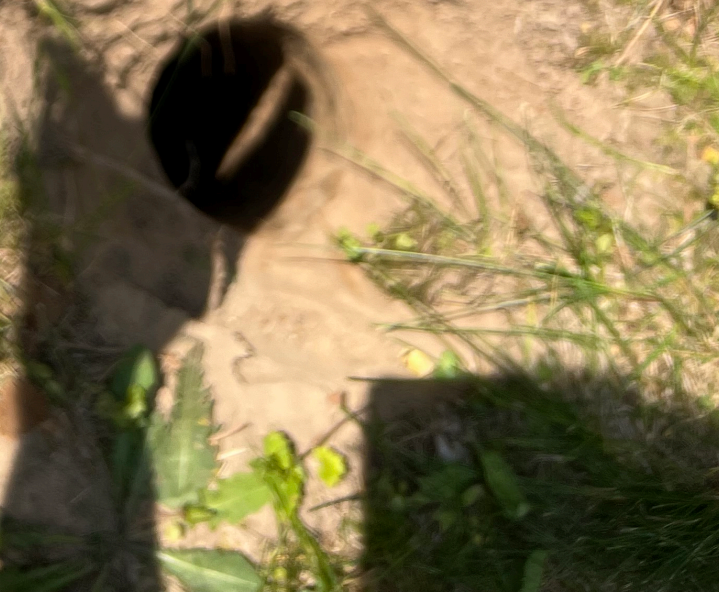
Soil Observations Log

My inspection indicates that this system is presently “non-compliant” in accordance with MPCA rules 7080.1500 Subp.4(B)(D) because of the lack of the required three foot separation between the bottom of the drainfield and bedrock.

Location of Project:		15123 Afton Hills Dr S, Afton, MN 55001			
Observations Made By:		Midwest Sewer Services		Date:	6/12/2023
Classification System:		USDA			
Soil Observation:		ST-1			
Surface Elevation of Observation		Same ground surface as last drainfield trench		Surface Elevation of Observation	
Depth In Inches	Rock %	<u>Soils Encountered</u>		Depth In Inches	Rock %
0-10 10-24 24-45		7.5YR 2.5/2 Silt Loam 7.5YR 4/4 Silt Loam 7.5YR 3/4 Sandy Loam Refusal At 45" Bedrock (Limestone)			
45"	Depth To End Of Soil Observation Or Bedrock			Depth To End Of Soil Observation Or Redox	
Same	Elevation Of Observation Relative To System			Elevation Of Observation Relative To System	
-31"	Depth To Bottom Of Distribution Media			Depth To Bottom Of Distribution Media	
=14"	Of Separation			Of Separation	
End Of Soil Observation At:		45"		End Of Soil Observation At:	
Limiting Soil Conditions At:		45"		Limiting Soil Conditions At:

Standing Water Present At:		None		Standing Water Present At:

Bottom Of Distribution Medium At: 31 Inches
