P.O. Box 10853 White Bear Lake, MN 55110 651-492-7550/Brian@Midwestsoiltesting.com		Brian Humpal MPCA Licensed Advanced Inspector	
SUBSURFACE SEWAGE T	REATMENT SYST	EM (SSTS) COMPLIANCE REPORT	
Date: November 3, 2023	Time: 11:30 AM	Owner: Amherst H. Wilder Foundation	
Inspection Address: PID #220	3120140001. May Twr	MN 55082 – Campground Shower

Compliance inspection report form

Existing Subsurface Sewage Treatment System (SSTS)

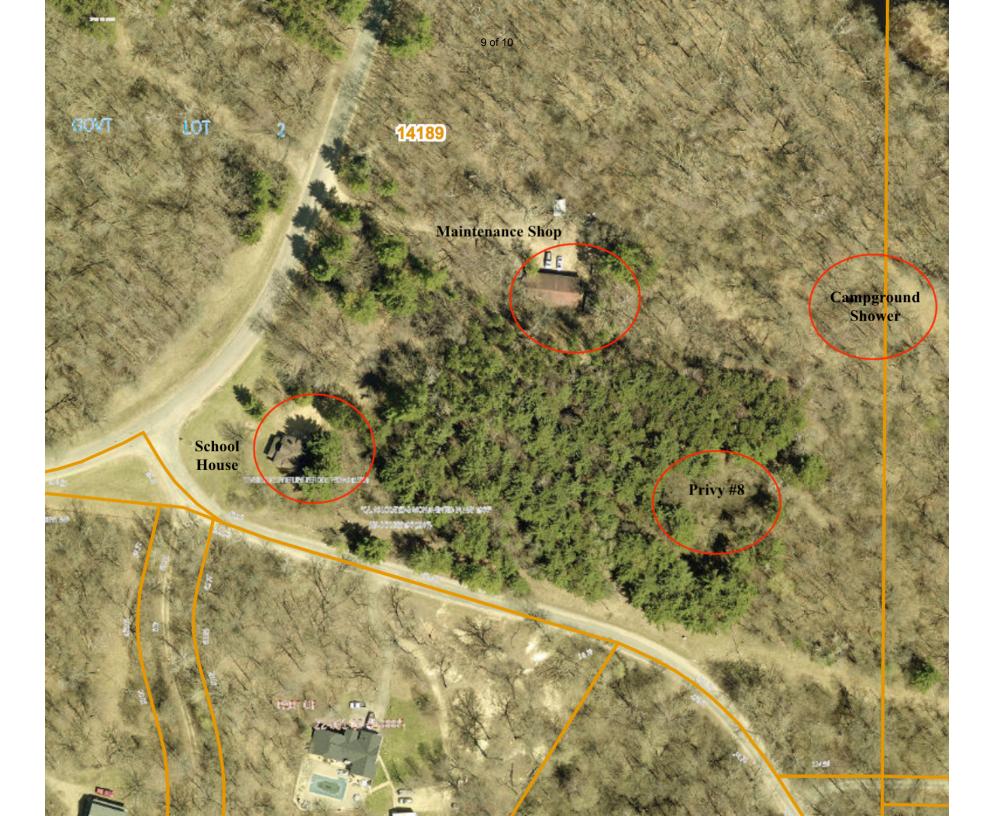
Soil Observations Log

Location of Project: PID #2203120140001, May Twp, MN 55082-Campground Shower								
Observations Made By: Midwest Sewer Ser						Date:	11/3/2023	
Classification System: USDA								
Soil Observation: ST-1			ST-1	Soil Observation:				
Surface Elevation of Observation		Same ground surface as last drainfield trench		Surface Elevation of Observation				
Depth In Inches	Rock %	Soils Encountered		Depth In Inches	Rock %	Soils Encountered		
0-8 8-22 22-25 25-30		10YR 3/4 Sar Trace 10YR 4 10YR 4/4	2/2 Silt Loam ady Clay Loam With e Of Gravel 4/4 Silt Loam Silt Loam With & 10YR 6/2 Redox					
25"	Depth 7	epth To End Of Soil Observation Or Redox			Depth T	o End Of Soil	Observation Or Redox	
Same Elevation Of Observation Relative To System					Elevation Of Observation Relative To System			
-40" Depth To Bottom Of Distribution Media					Depth To Bottom Of Distribution Media			
=0" Of Separation				Of Separation

End Of Soil Observation At: 30"					End Of Soil Observation At:			
Limiting Soil Conditions At: 25"					Limiting Soil Conditions At:			
Standing Water Present At: None					Standing Water Present At:

Bottom Of Distribution Medium At: 40 Inches
