Midwest Sewer Services

P.O. Box 10853 White Bear Lake, MN 55110	Brian Humpal
651-492-7550/Brian@Midwestsoiltesting.com	MPCA Licensed Advanced Inspector
SUBSURFACE SEWAGE TREATMENT SYST	1

Date: April 24, 2024Time: 11:00 AMOwner: Ruth & OJ RustadInspection Address: 15350 113th St N, Stillwater Twp, MN 55082

Compliance inspection report form

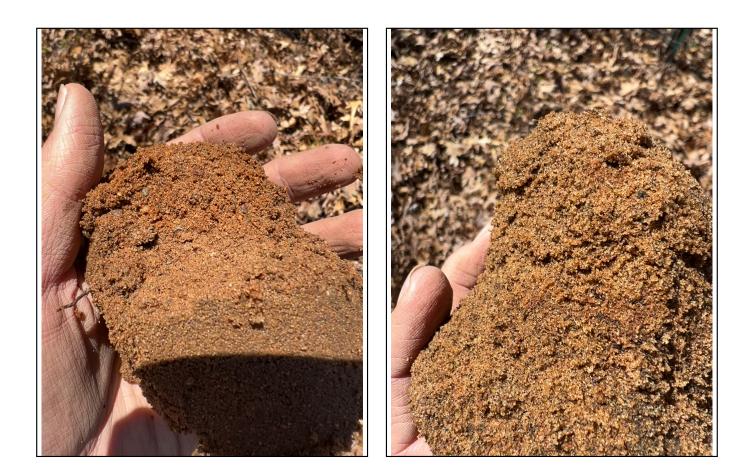
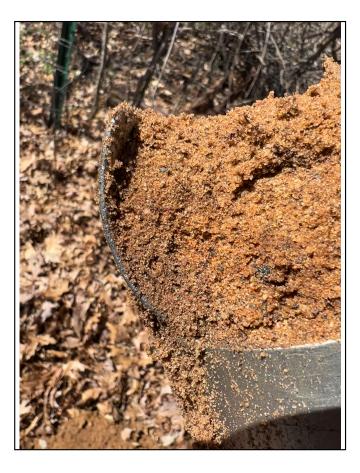
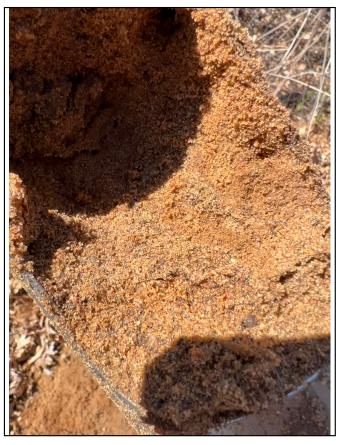
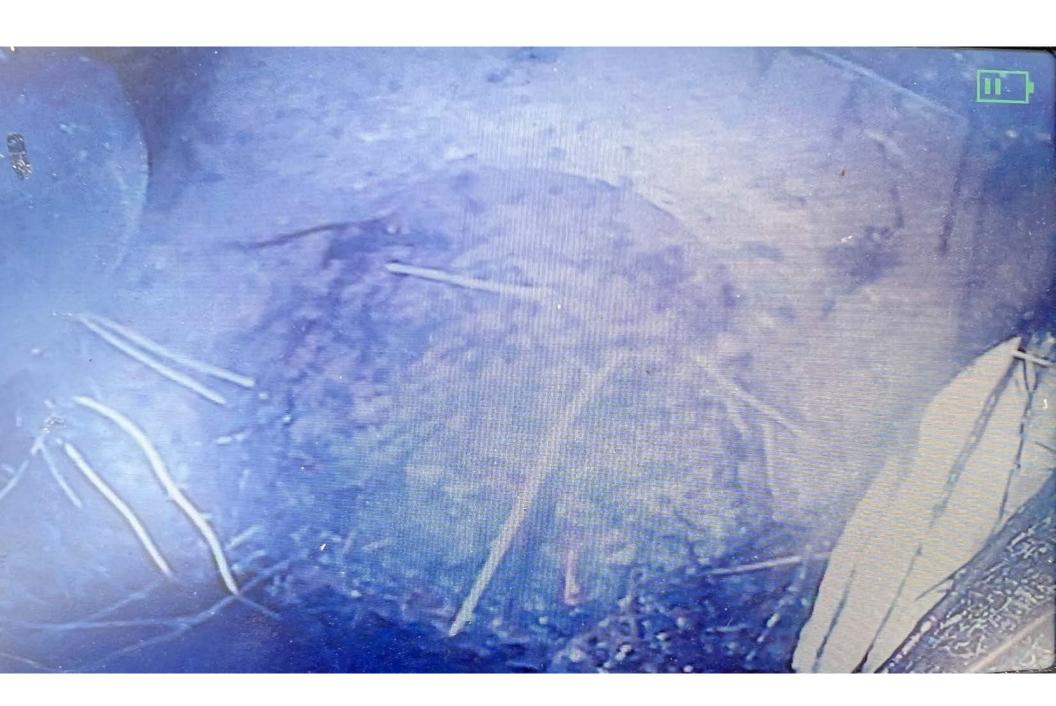
Soil Observations Log

Location of Project: 15350 113TH St N, Stillwater Twp, MN 55082								
Observations Made By: Midwest Sewer Ser						Date:	4/24/2024	
0	Classific	ation System:	USDA					
Soil Observation: ST-1				Soil C	bservation:	ST-2		
Surface Elevation of Observation		99.40' Benchmark = 100.00' garage floor threshold at overhead door		Surface Elevation of Observation			95.90'	
Depth In Inches	Rock %	Soils Encountered		Depth In Inches	Rock %	Soils Encountered		
0-14 14-19 19-33 33-50 50-60 60-70	≈20	Wii 10YR 2/2 Loam 10YR 3/4 Fin 10YR 3/4 Medi With Loamy 7.5YR 4/4 San With 7.5YR 5/	ne To Loamy Sand th Gravel y Fine to Loamy Sand Id To Medium Sand um Sand (Saturated) Fine Sand Pockets dy Loam (Saturated) 8 & 10YR 7/2 Redox H Medium Sand			10YR 3 10YR 3/4 7.5 10YR 4/4 7.5YR 5/8 10YR 5/4 7.5YR 4/4 f	2/2 Medium Sand Medium Sand With YR 5/8 Redox Medium Sand With 8 & 10YR 7/2 Redox Medium Sand With Fine Sand Layers With YR 5/8 Redox

94.40' Elevation To Bottom Of Distribution Media						n To Bottom Of Distribution Media		
-95.23' Depth To Redox Or End Of Observation =0'/0" Of Separation				-93.98' Depth To Redox Or End Of Observation -0'/0" Of Separation				
					,			
End Of Soil Observation At: 93.57'/70"				End Of Soil Observation At: 90.07'/70'				
Limiting Soil Conditions At: 95.23'/50"				Limiting Soil Conditions At: 93.48'/23"				
Standing Water Present At: None				Standing Water Present At: None				
Bottom Of Distribution Medium At: 60 Inches Or Elevation 94.40' At Soil Probe 1 60 Inches Or Elevation 90.90' At Soil Probe 2								
Signature:
