# Midwest Sewer Services

## **SUBSURFACE SEWAGE TREATMENT SYSTEM (SSTS) COMPLIANCE REPORT**

**Inspection Address:** 4009 Ideal Ave N, Lake Elmo, MN 55042

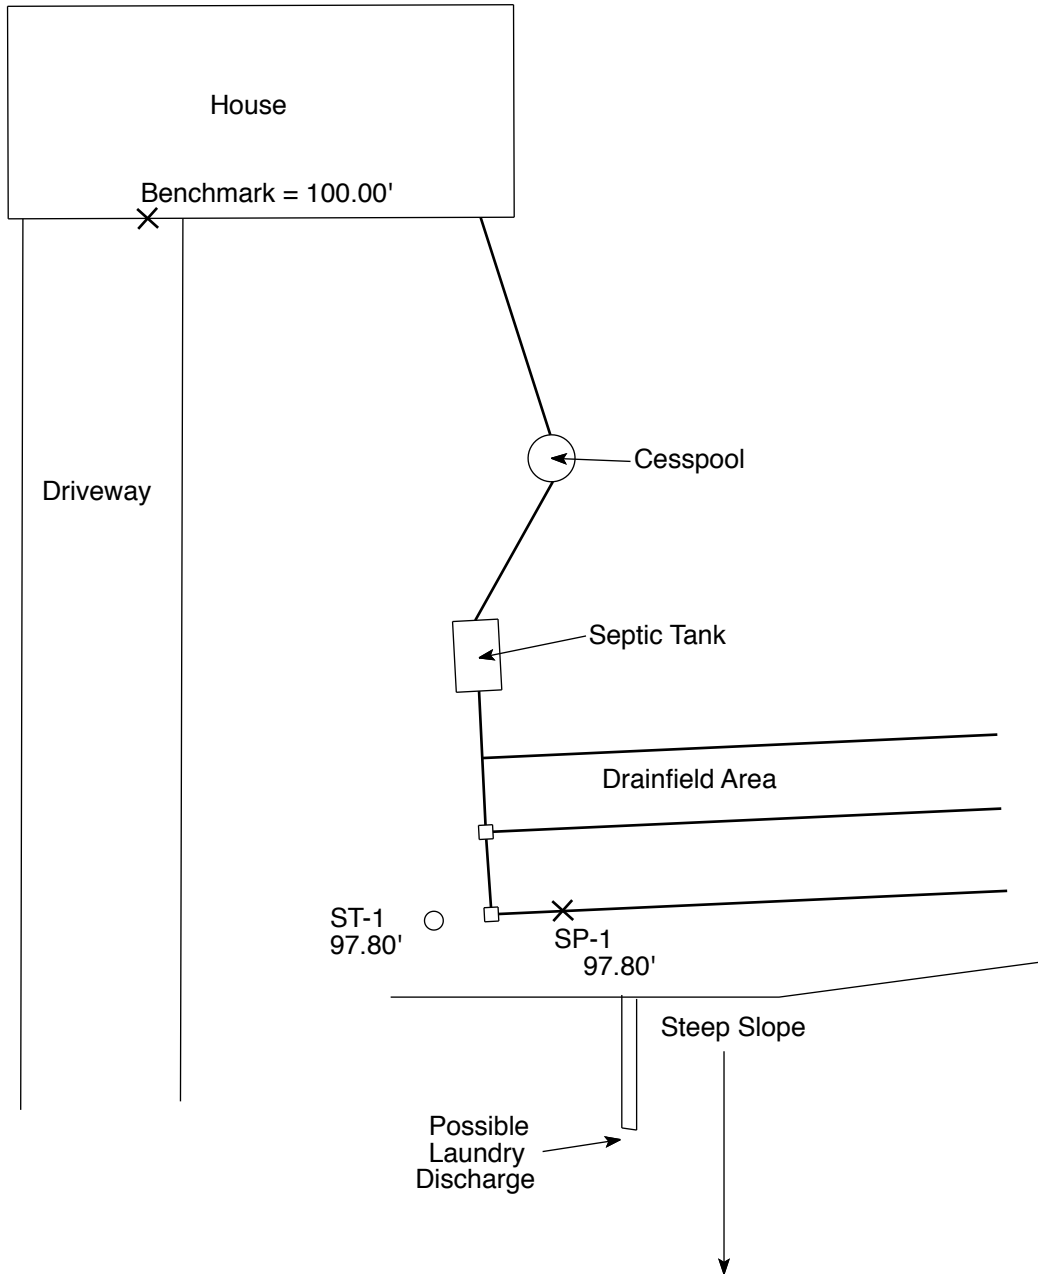
**4009 Ideal Ave N, Lake Elmo, MN 55042**

Possible laundry discharge on the hillside (see site sketch).

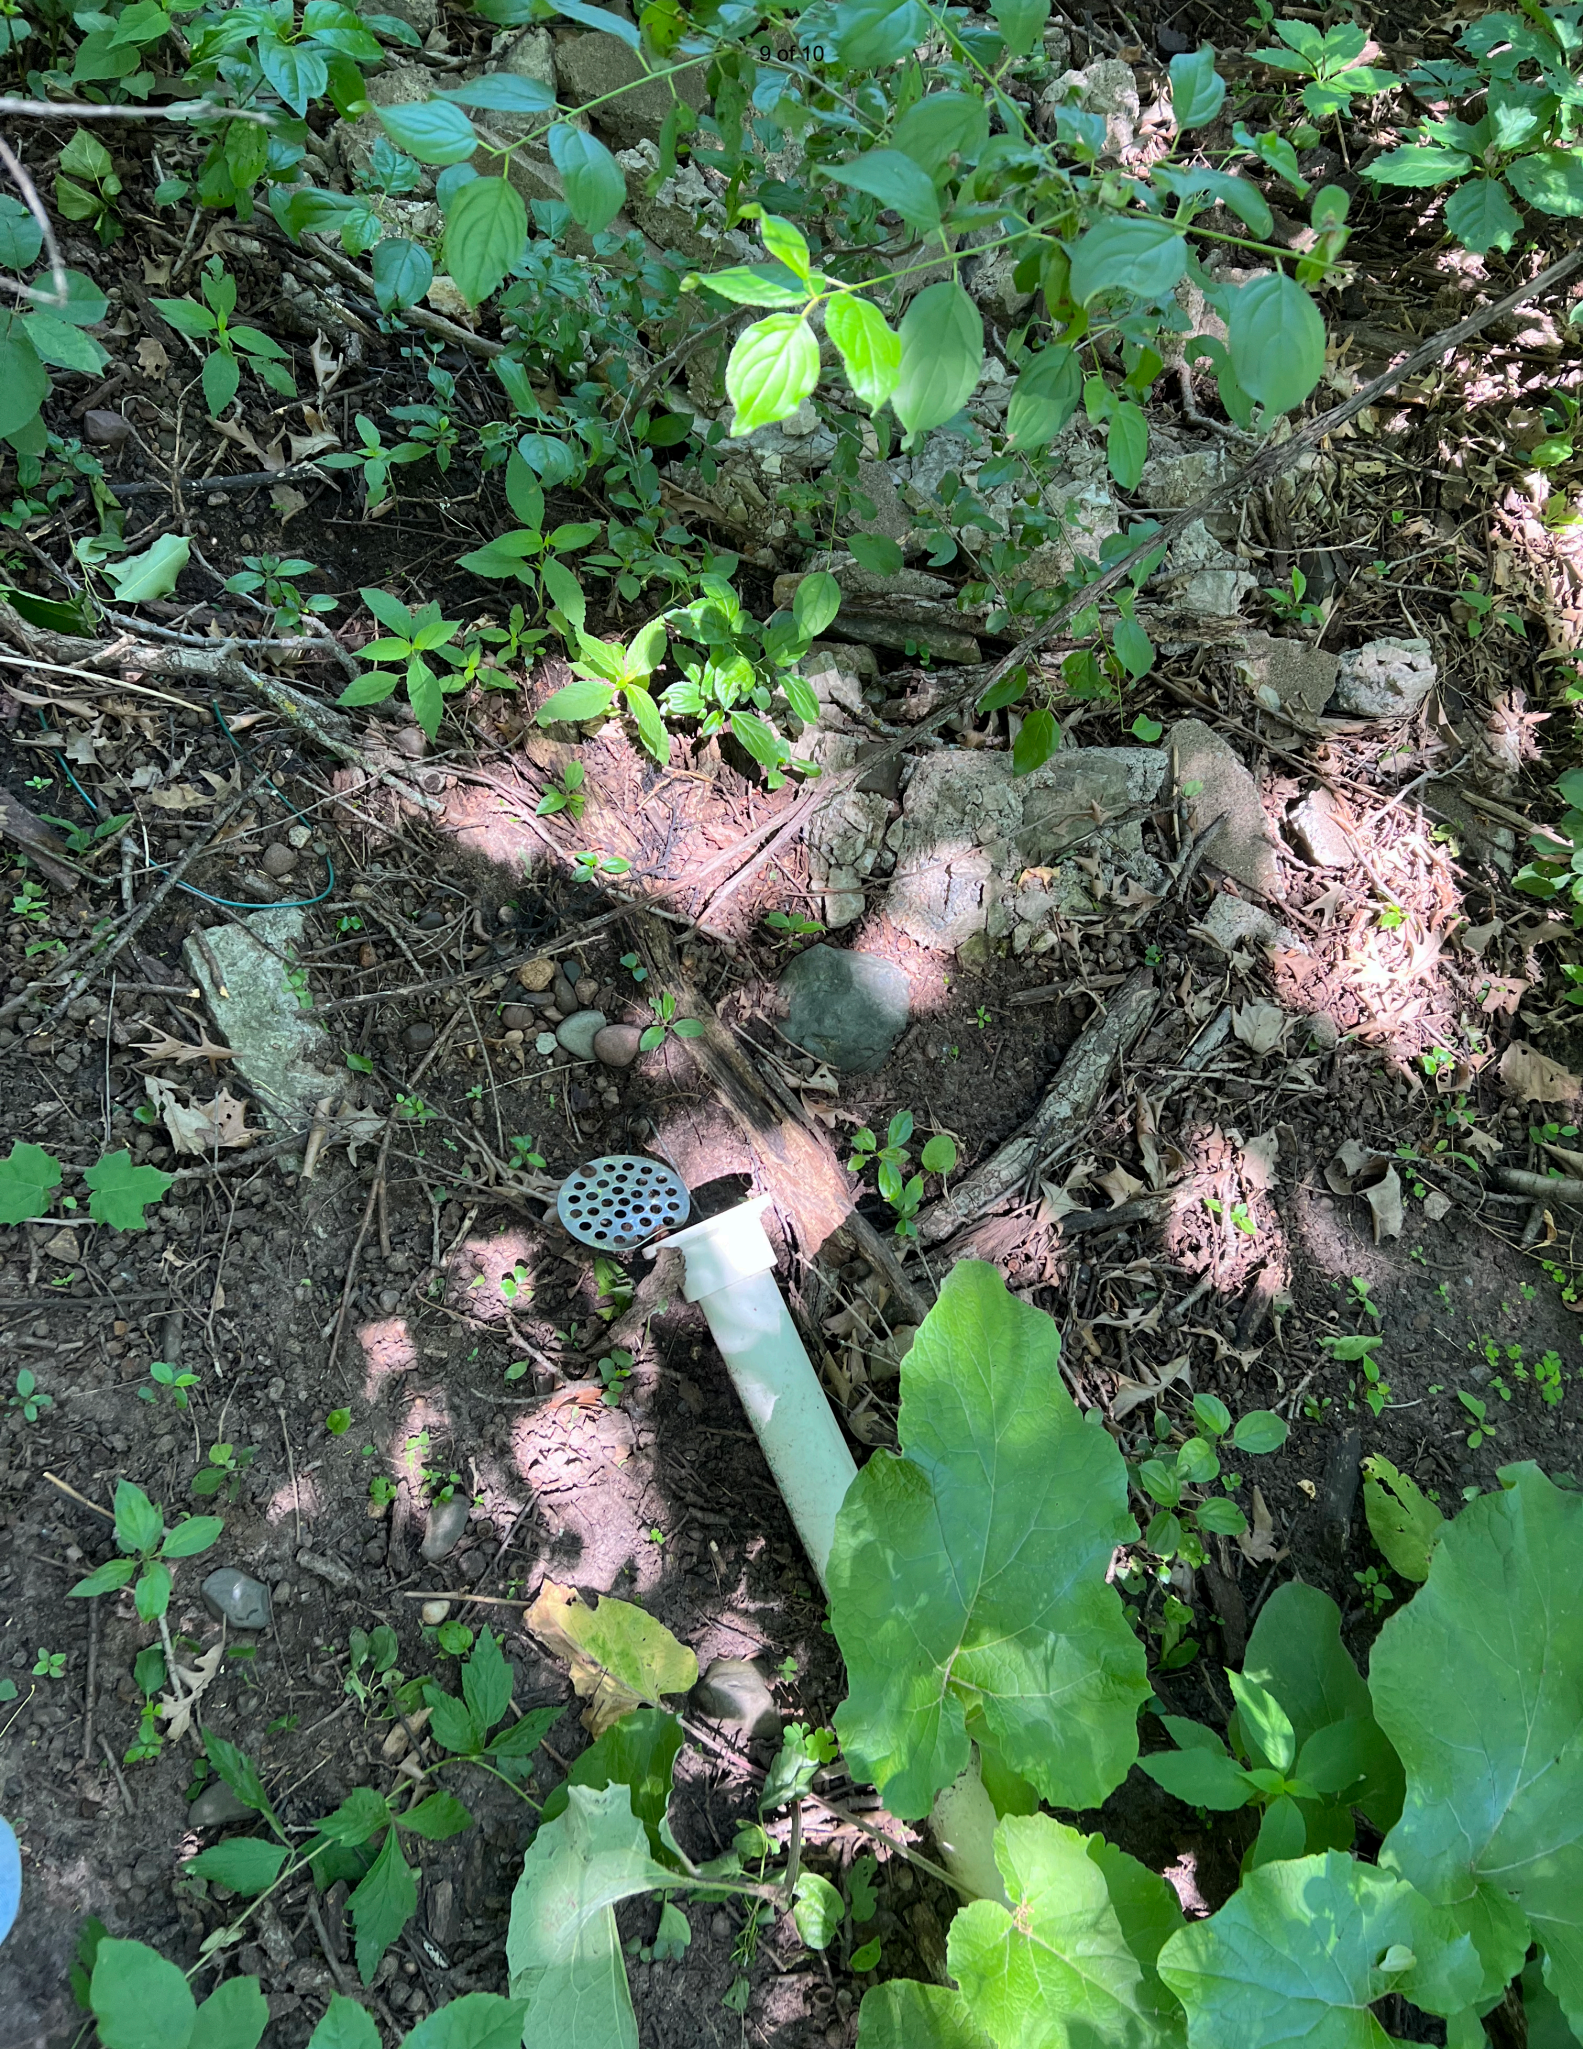
## Soil Observations Log

Location of Project:		4009 Ideal Ave N, Lake Elmo, MN 55042			
Observations Made By:		Midwest Sewer Services		Date:	6/10/2024
Classification System:		USDA			
Soil Observation:		ST-1		Soil Observation:	
Surface Elevation of Observation		97.80'		Surface Elevation of Observation	
		Benchmark = 100.00' garage floor threshold at overhead door			
Depth In Inches	Rock %	<u>Soils Encountered</u>		Depth In Inches	Rock %
0-13	≈25	10YR 2/2 Sandy Loam (Disturbed) With Gravel			
13-36		10YR 2/2 Sandy Loam (Disturbed)			
36-50		10YR 3/4 Loamy Sand			
50-60		7.5YR 4/4 Sandy Loam			
60-67		7.5YR 4/4 Clay Loam With Faint 7/5YR 5/8 Redox

93.63'	Elevation To Bottom Of Distribution Media		Elevation To Bottom Of Distribution Media		
-92.80'	Depth To Redox Or End Of Observation		Depth To Redox Or End Of Observation		
=0.83/10"	Of Separation		Of Separation		
End Of Soil Observation At:		92.22'/67"		End Of Soil Observation At:	
Limiting Soil Conditions At:		92.80'/60"		Limiting Soil Conditions At:	
Standing Water Present At:		None		Standing Water Present At:	
Bottom Of Distribution Medium At: 50 Inches Or Elevation 93.63' At Soil Probe 1
