Property information

Local tracking number: _____
Parcel ID# or Sec/Twp/Range: 0403021220006 Reason for Inspection _____ Transfer of deed _____
Local regulatory authority info: Washington County
Property address: 11835 IMPERIAL AVE N, CITY OF GRANT
Owner/representative: RAIOLO STEPHEN F & MARY M Owner's phone: N/A
Brief system description: 2-1000 septic tanks and 1000 gallon lift tank going to five 80' lines

Property Address: 11835 IMPERIAL AVE N, CITY OF GRANT

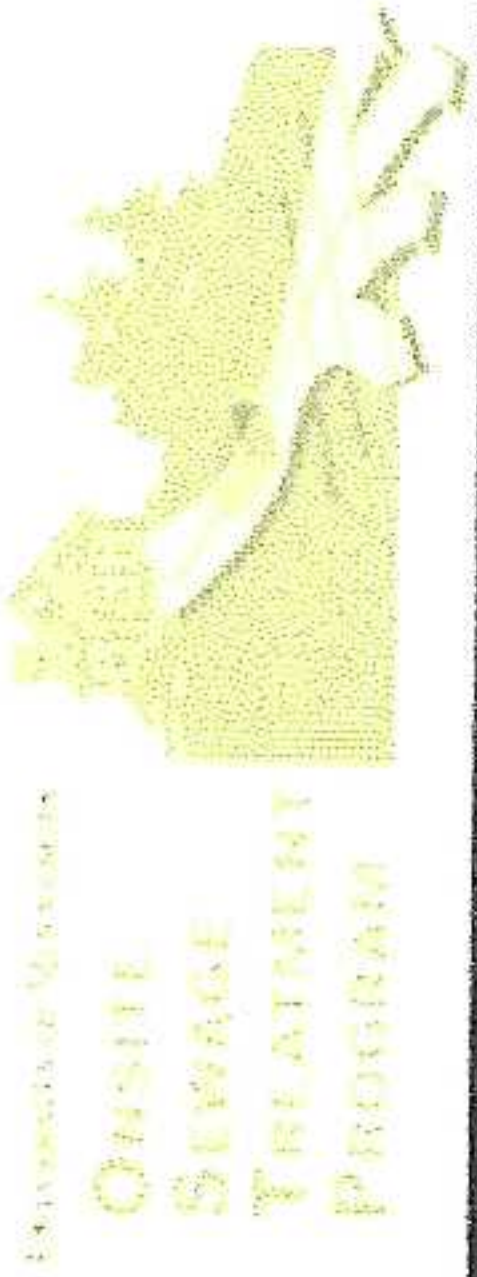
AS BUILT 1994 SYSTEM

INSTALLED by

J.A. CHAVES EXCAVATING
1077 Omaha Avenue North
STILLWATER, MINNESOTA 55082
(612) 436-7732 or 436-7899

SHEET NO: PERMIT # 8794032 OF _____

CALCULATED BY J CHAVES DATE 7-28-94

SCALE 1" = 20' APPROX
