ZIERKE SOIL TESTING

Compliance inspection report form

Existing Subsurface Sewage Treatment System (SSTS)

Property information	Local tracking number:
Parcel ID# or Sec/Twp/Range: 3103220140010	Reason for Inspection Sale
Local regulatory authority info: Washington County	
Property address: 10996 185 th St N Marine on St Croix, MN 55	5047
Owner/representative: Barb Flug	Owner's phone: 651-890-9692
Brief system description: 1200 gallon septic tank, 1000 gallon life	it tank, pressure bed dispersal system
System status	
System status on date (mm/dd/yyyy): 7/8/2024	
☐ Compliant – Certificate of compliance*	☐ Noncompliant – Notice of noncompliance
(Valid for 3 years from report date unless evidence of an imminent threat to public health or safety requiring removal and	Systems failing to protect ground water must be upgraded, replaced, or use discontinued within the time required by local ordinance.
abatement under section 145A.04, subdivision 8 is discovered or a shorter time frame exists in Local Ordinance.)	An imminent threat to public health and safety (ITPHS) must be upgraded, replaced, or its use discontinued within ten months of receipt

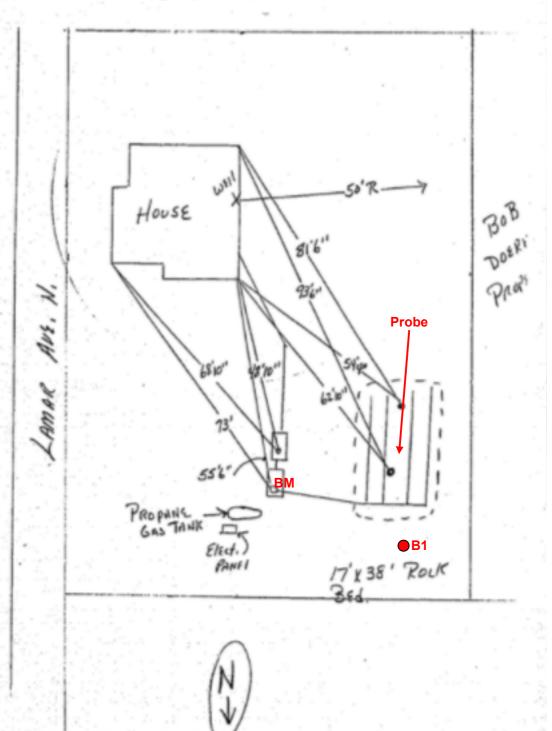
6ARY Flub
10996 18546.54.
MARINE MN.
PERINIT # BINL 128
INSTAILED 1987
SCALE 1"=24"

Relative Elevations in Decimal Feet:

B1: 100.0

B1 Redox: 93.0+ Bottom of rock: 97.5 B1 Separation: 4.5+ Benchmark: 99.3 (cover on lift tank)

Site notes from 7/3/2024 inspection are in RED
