ZIERKE SOIL TESTING

Compliance inspection report form

Existing Subsurface Sewage Treatment System (SSTS)

Brief system description: 1250 gallon septic tank, 1000 gallon lift tank, mound dispersal system

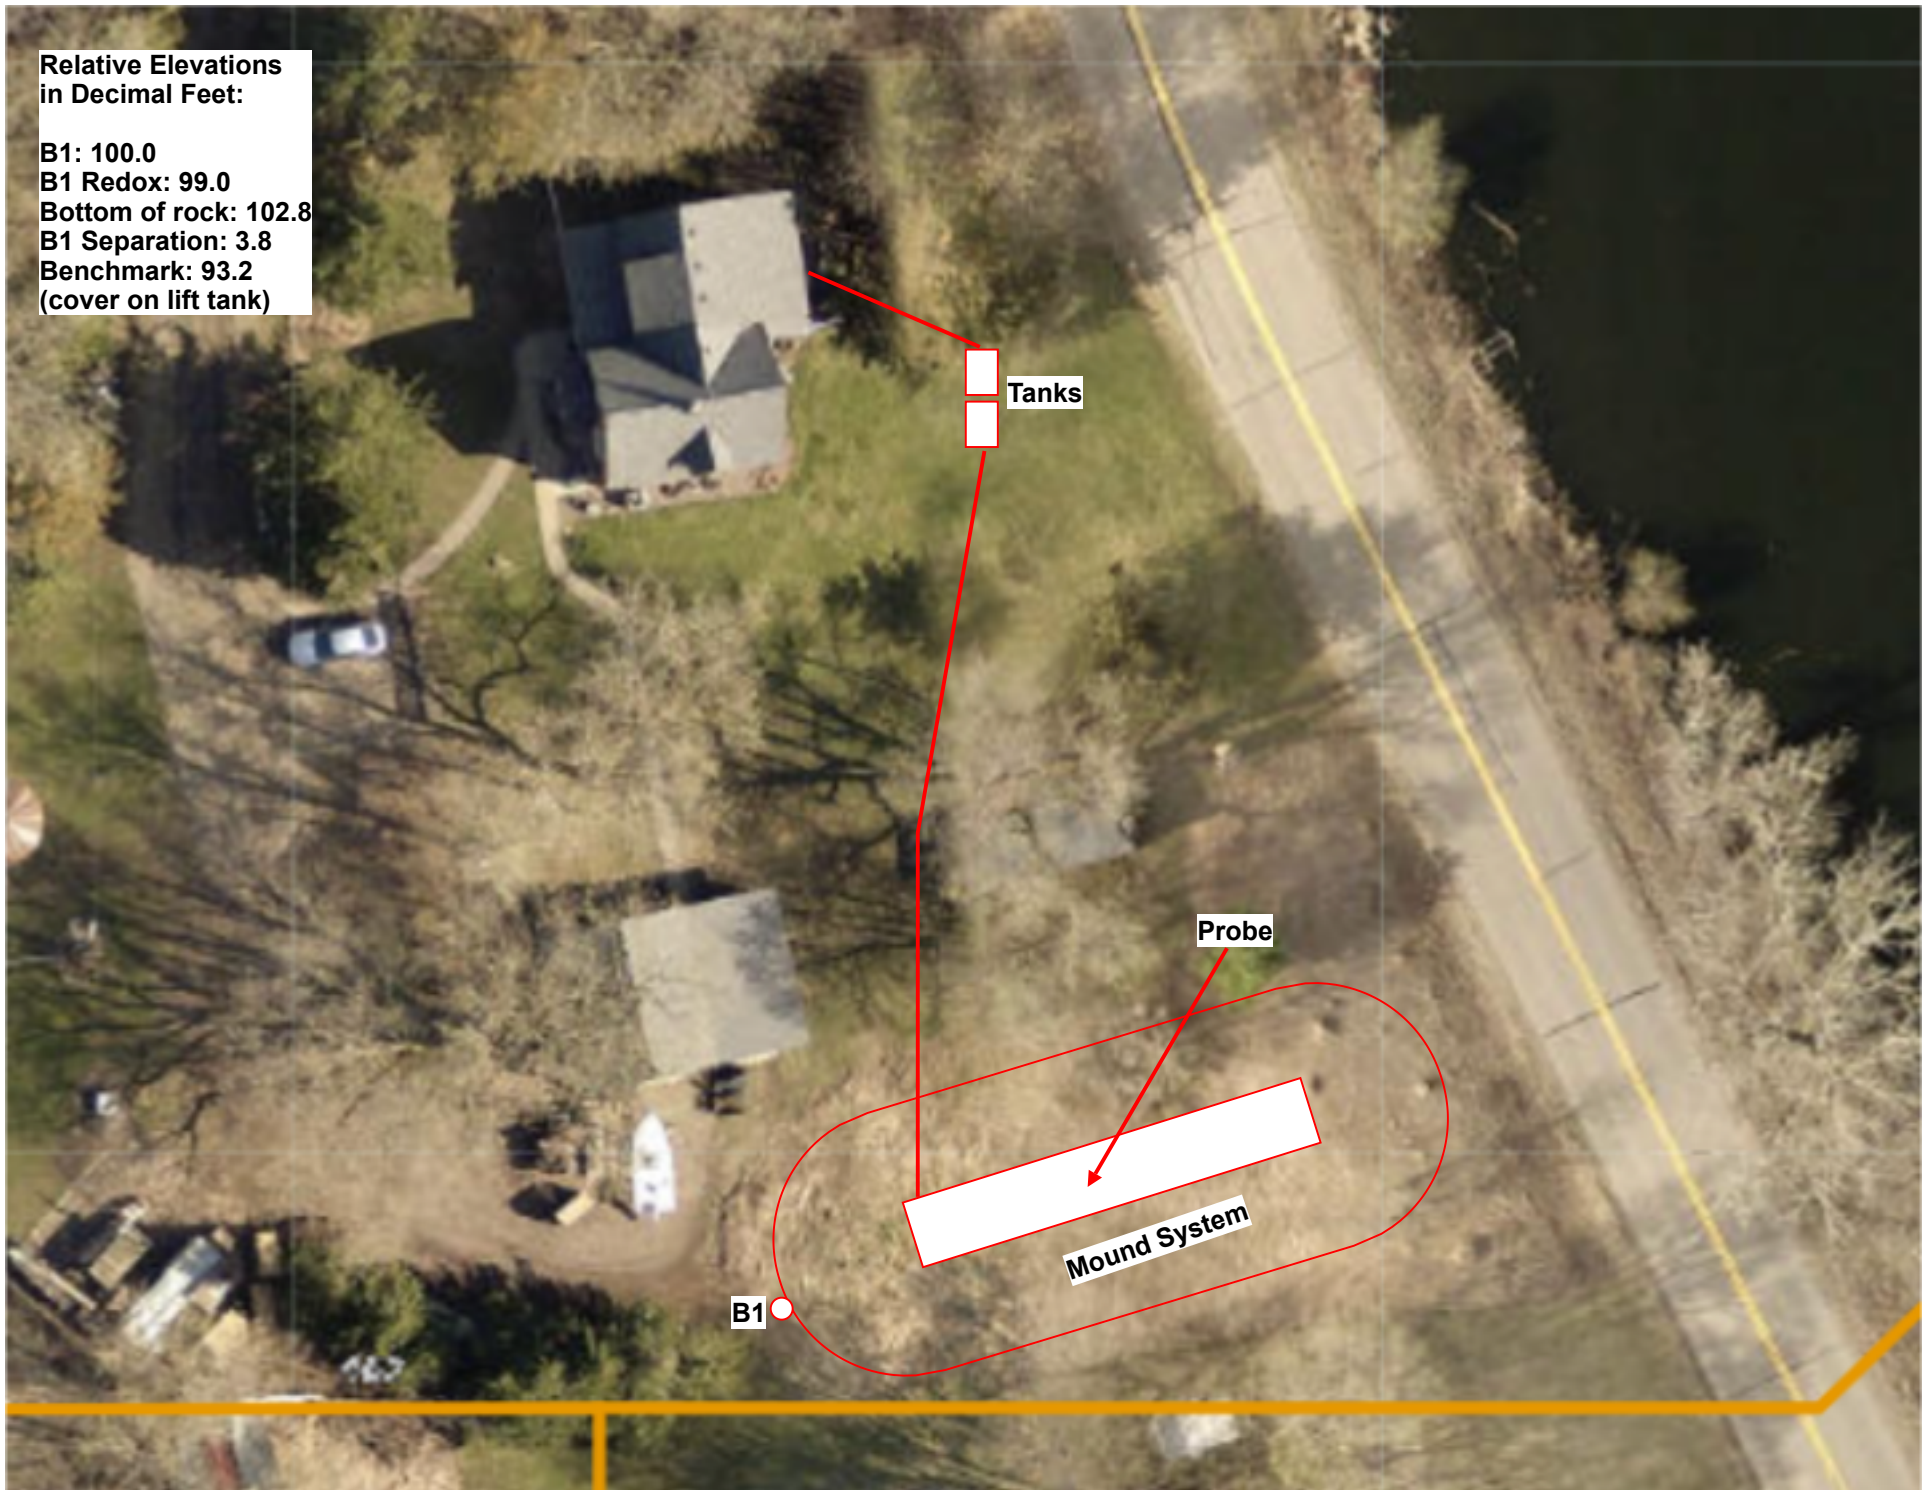
B1: 100.0

B1 Redox: 99.0

Bottom of rock: 102.8

B1 Separation: 3.8

Benchmark: 93.2

(cover on lift tank)

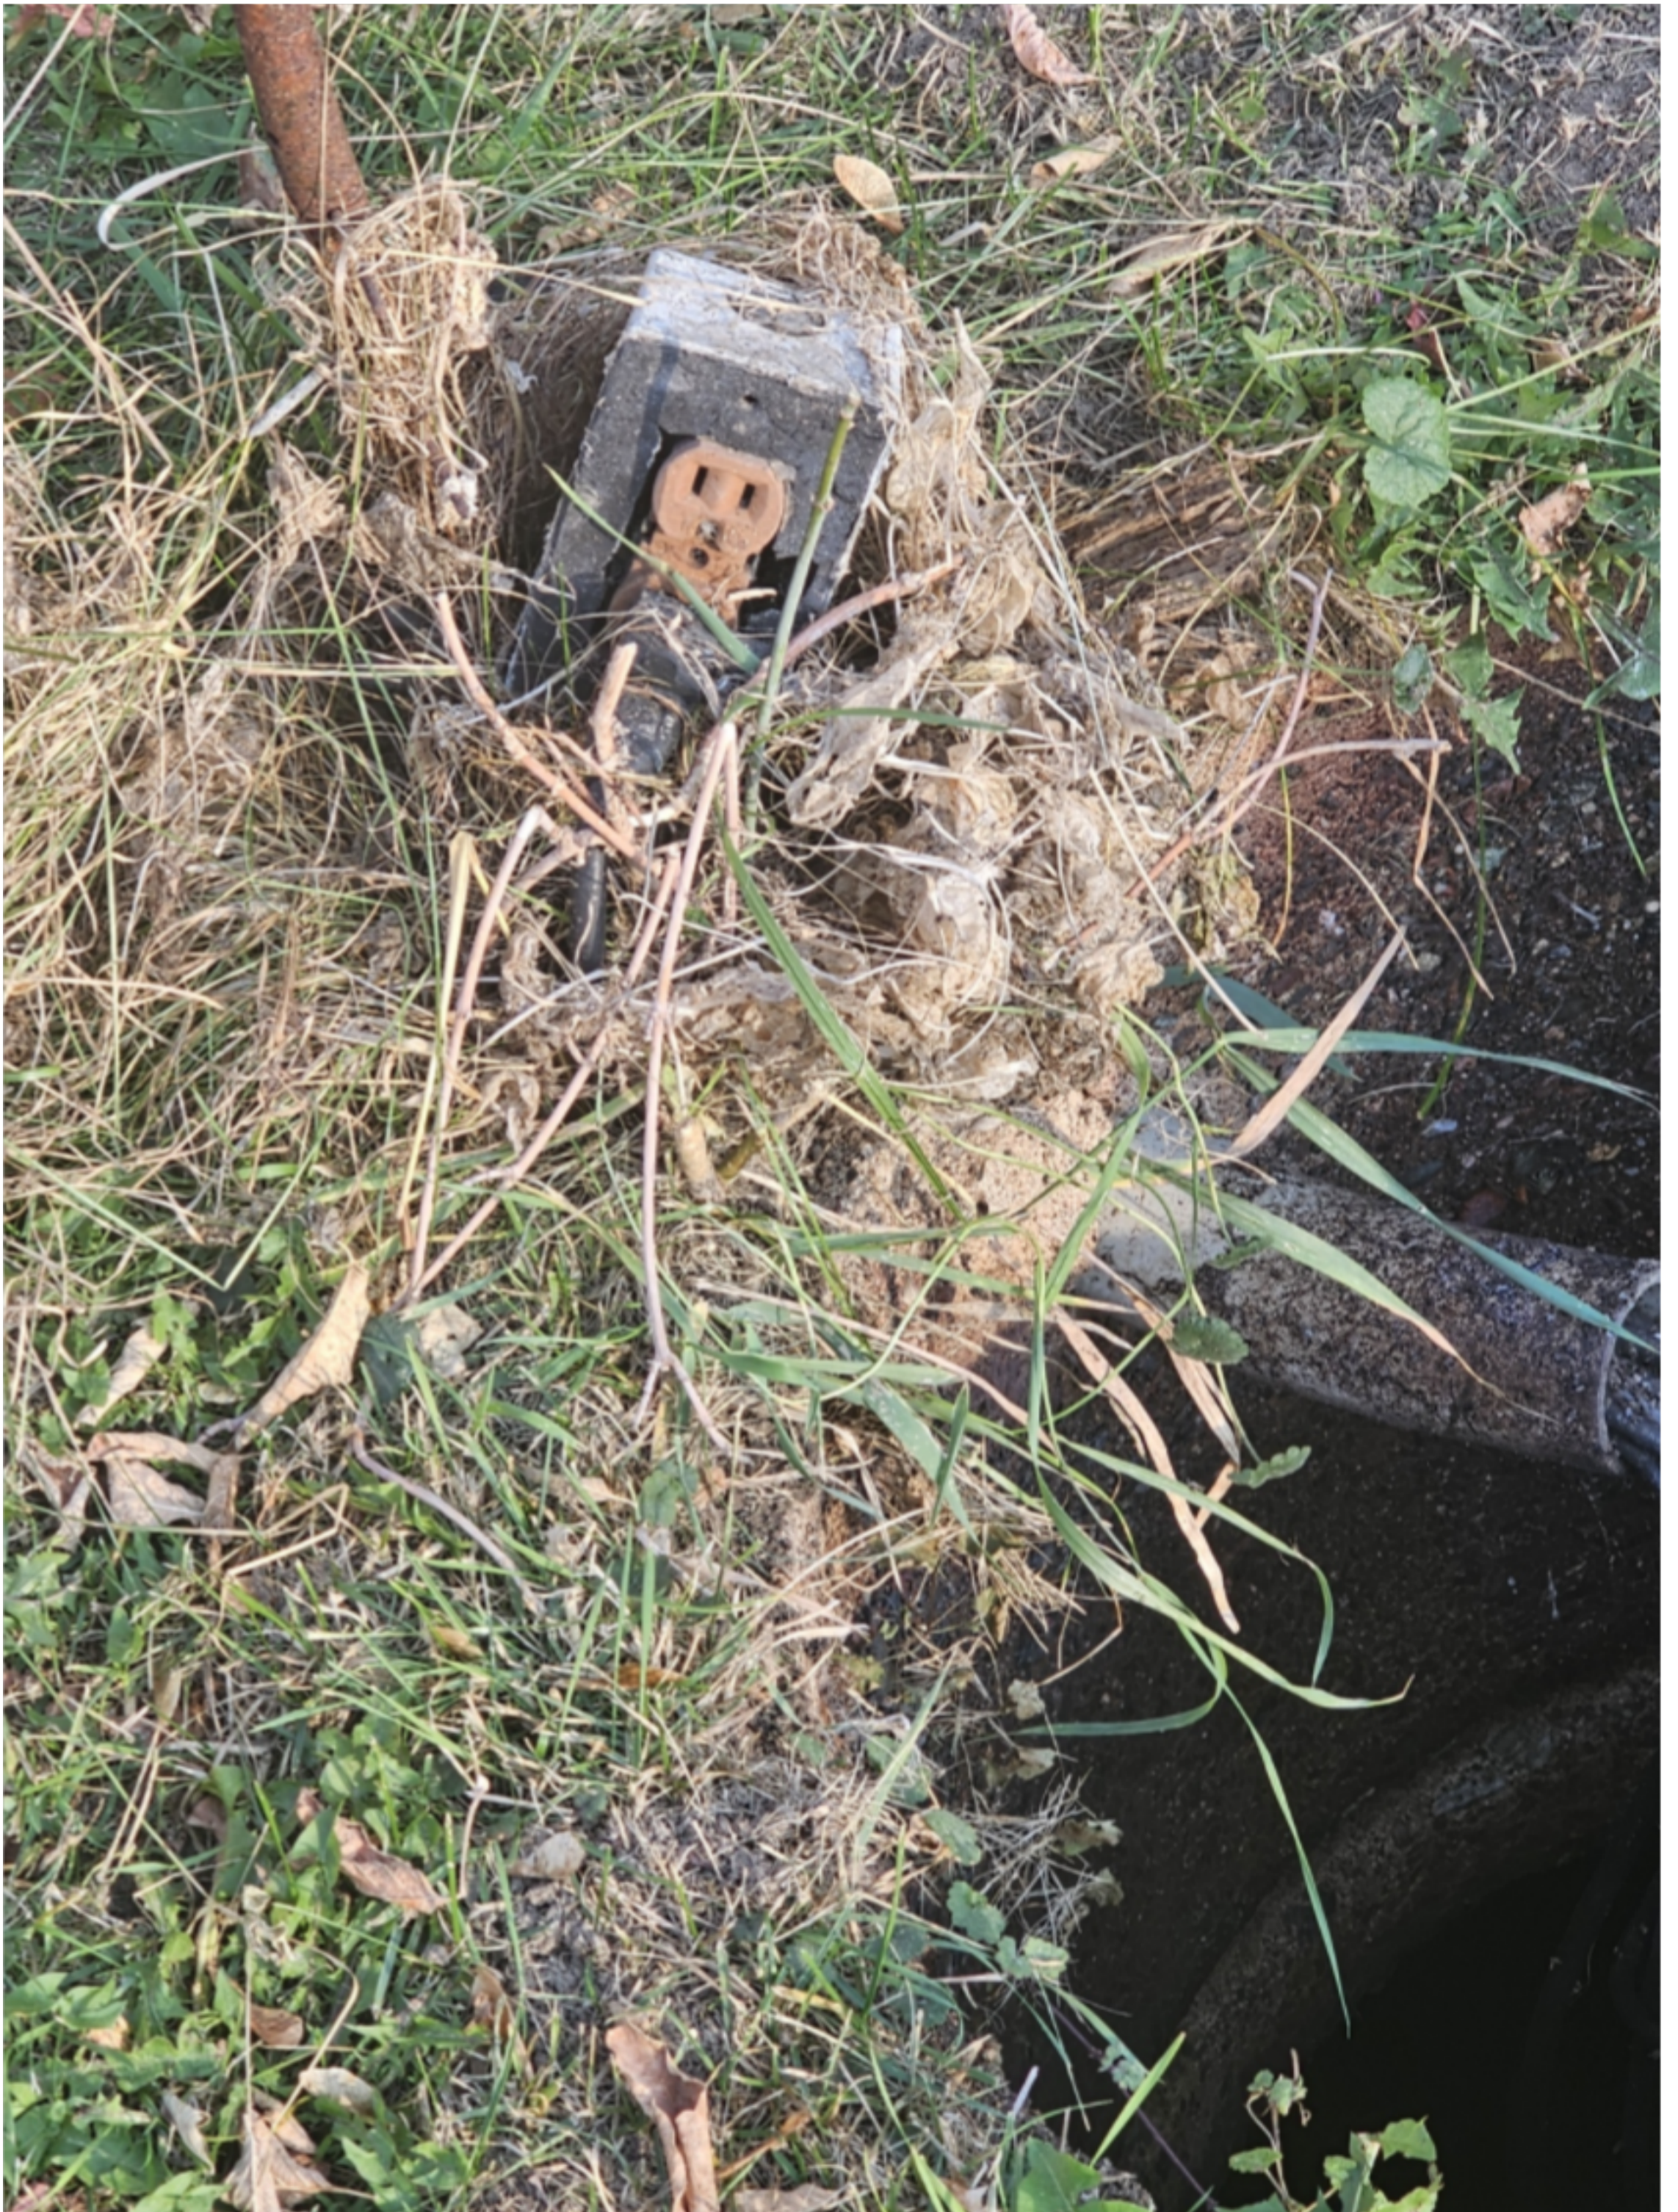
System is functioning normally and has soil separation. However, the electrical outlet at the lift is starting to fall apart and is presently only protected by a pail that is set on top of it. Recommend having an electrician properly wire the pump and and place a weatherproof receptacle at the tank.
