Compliance inspection report form

Existing Subsurface Sewage Treatment System (SSTS)

Property information	Local tracking number:
Parcel ID# or Sec/Twp/Range: <u>0503021110009</u> Lo	cal regulatory authority: WASHINGTON COUNTY
Property address: 11940 HONEYE AVENUE N STILLWATER	MN
Owner/representative: MEATH RHONDA AND JOSEPH	Owner's phone:
Brief system description: 2)1250-GALLON SEPTIC TANKS, 100	0-GALLON LIFT TANK AND GRAVITY DRAINFIELD
System status	
System status on date (mm/dd/yyyy): 11/15/2024	
	☐ Noncompliant – Notice of noncompliance
(Valid for 3 years from report date unless evidence of an imminent threat to public health or safety requiring removal and abatement under section 145A.04, subdivision 8 is discovered or a shorter time frame exists	An imminent threat to public health and safety (ITPHS) must be upgraded, replaced, or its use discontinued within ten months of receipt of this notice or within a shorter period if required by local ordinance or under section 145A.04 subdivision 8.

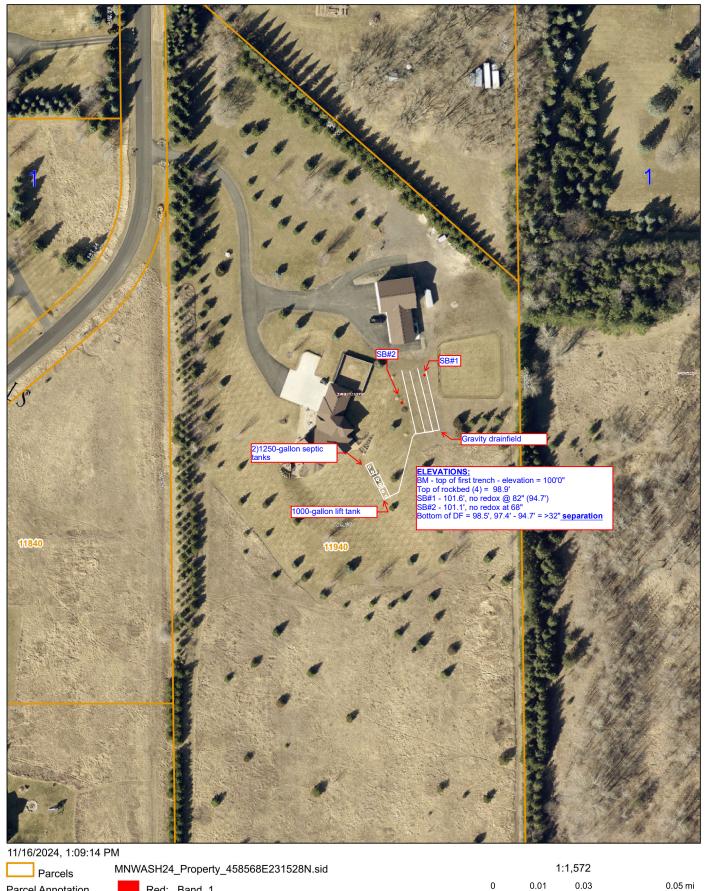
ArcGIS Web Map

Comments: Benchmark = Top of rockbed inj last trench. Assumed elevation = 100'0". Soil boring #1 indicated no redoximorphic mottling at 72". The system does meet the required 36" vertical separation from seasonally saturated soils. The system consists of two 1250-gallon septic tanks, a 1000-gallon lift tank and gravity trenches. The baffles were checked and are o.k. The lift pump was manually run and operable. The tanks were pumped at the time of inspection and found to be in good condition. The system was dosed with approximately 300 gallons of effluent with no noticeable signs of excess moisture or ponding observed in the rockbed of the drainfield. This inspection is not a warranty or guarantee, either written or implied, of future or long-term hydraulic functionality/performance, but rather a determination if the systems use is/may cause pollution and/or adverse harm to the environment, groundwater or public health and safety at the time of this inspection. No quarantee can be made on future hydraulic performance, or the performance of system components (pumps, controls, etc.). Changes in use can cause any system, failing or compliant, to become hydraulically overloaded and ultimately fail. Owner/buyer assumes full responsibility for the long-term performance of this system as well as any future upgrade, repairs or replacement costs. Liability is limited to the cost of this inspection.
