SUBSURFACE SEWAGE TREATMENT SYSTEM (SSTS) COMPLIANCE REPORT

Inspection Address: 289 Ideal Ave N, Mahtomedi, MN 55115

Log Of Soil Borings

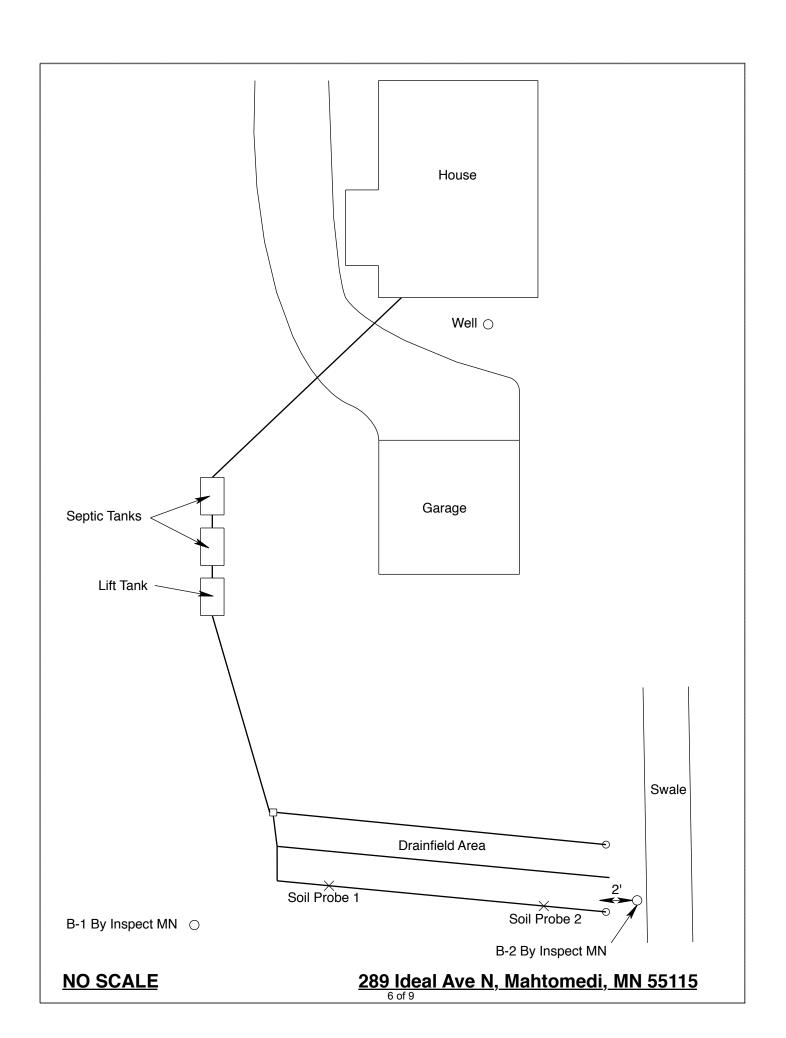
Date of Inspection: October 24, 2016	Time: 1:45 AM				
Property Address: 289 Ideal Ave N, Mahtomedi, MN	Zip: 55115				
Property Owner: Estate of Marla Wolter	Phone:				
Tank(s) Tank(s)Material Soil Treatment System Septic 2 Fiberglass ⊠Rock trench Aerobic Plastic Gravelless trench Lift Metal Chamber trench Holding ⊠Concrete Seepage bed Other: Block Mound Other At-grade	Other Alternative system Experimental system Cesspool system Other system				
Are the tank maintenance covers accessible? Yes No *If no, proper maintenance must be performed through the maintenance holes. Maintenance hole covers should be made accessible to the ground surface to facilitate access and proper maintenance of the system.
