Compliance Inspection Form
Existing Subsurface Sewage Treatment Systems (SSTS)

System status on date (mm/dd/yyyy): 5/12/2017

Property address: 13030 182nd St N Marine on St Croix, MN 55047

Brief system description: Septic tank and gravity rock trench drainfield with 18 inches of rock under the pipe

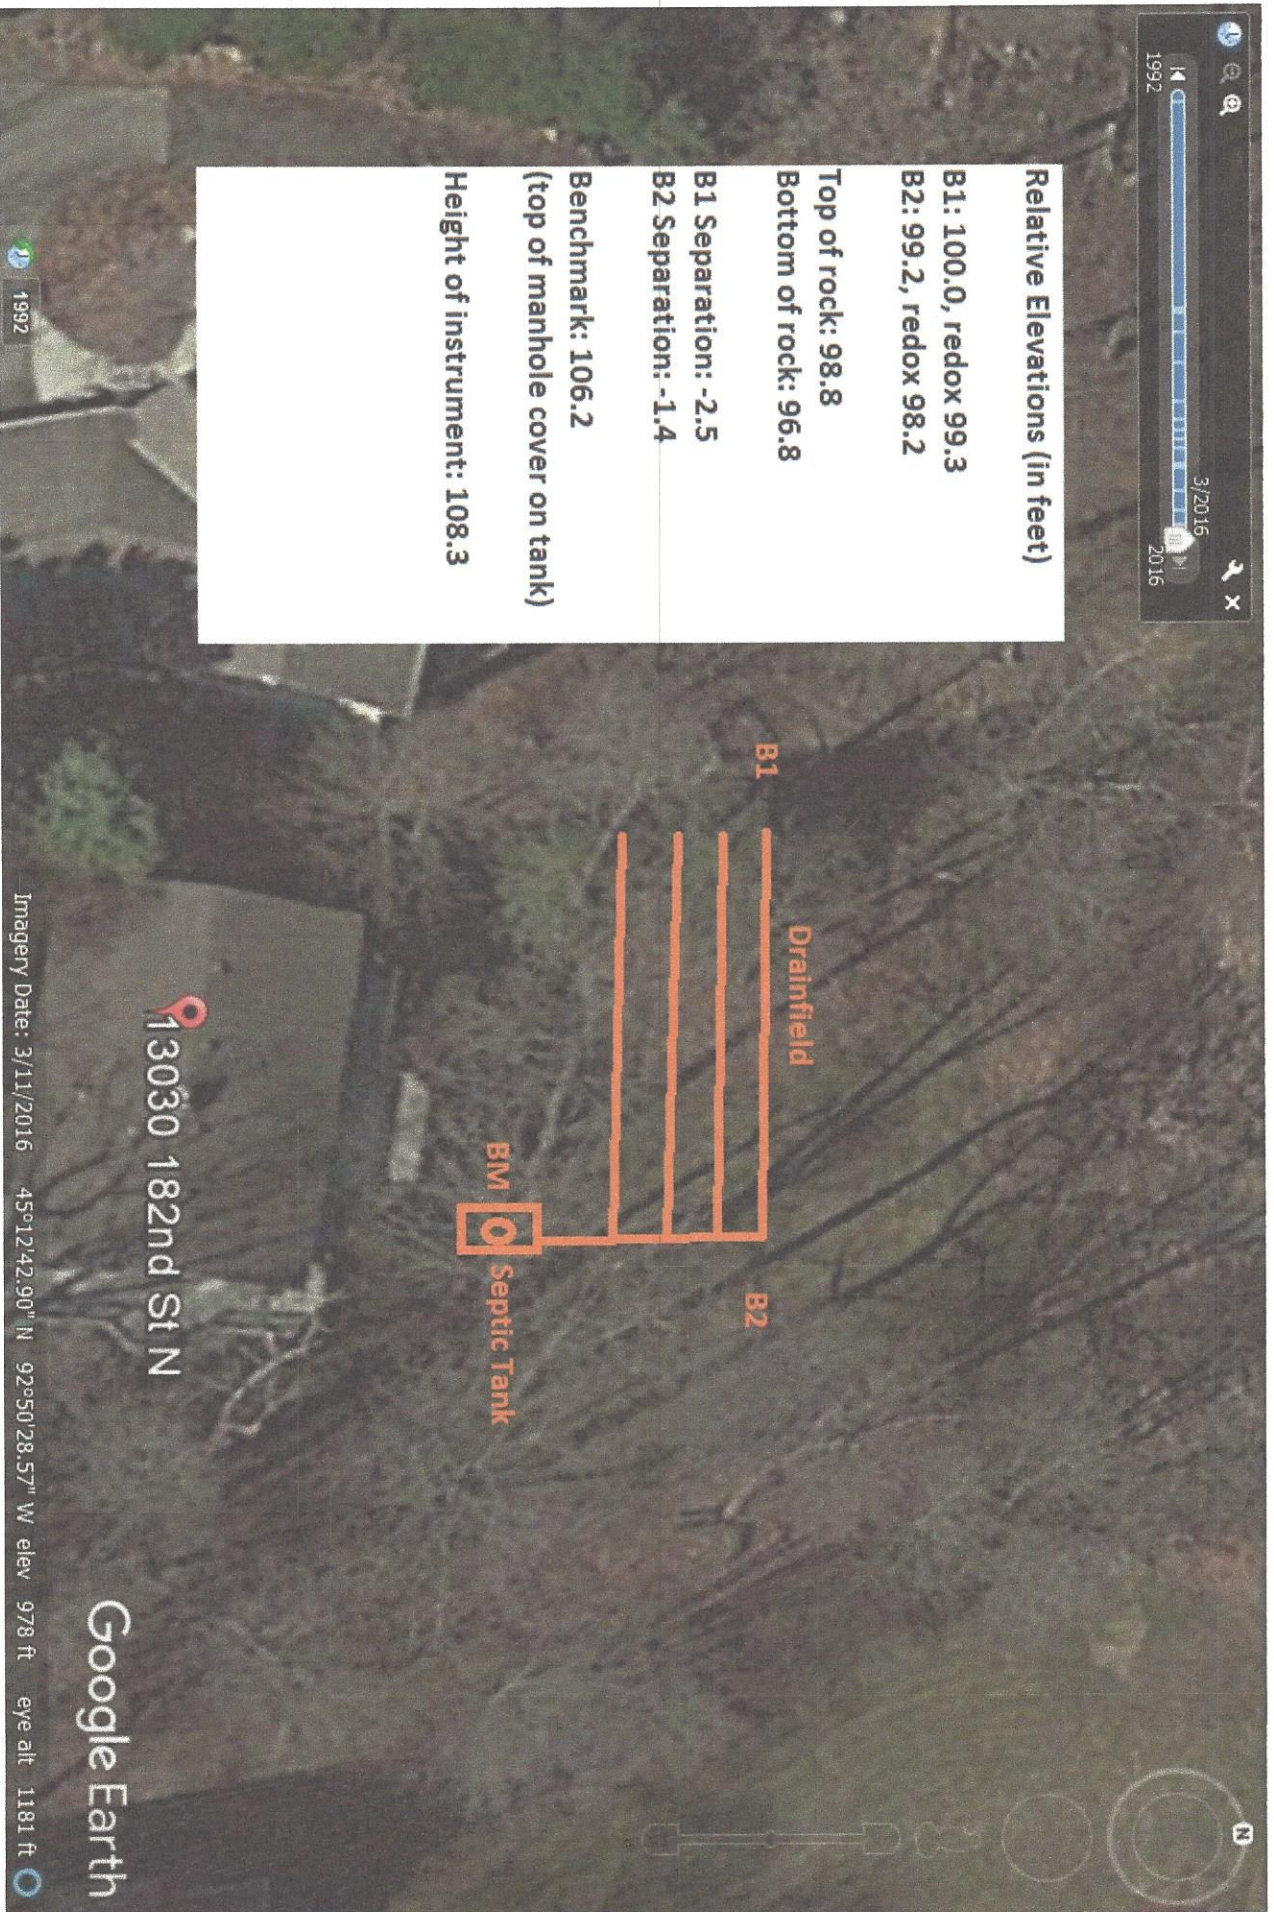
13030 182nd St N

B1: 100.0, redox 99.3
 B2: 99.2, redox 98.2
 Top of rock: 98.8
 Bottom of rock: 96.8
 B1 Separation: -2.5
 B2 Separation: -1.4
 Benchmark: 106.2
 (top of manhole cover on tank)
 Height of instrument: 108.3
