520 Lafayette Road North St. Paul, MN 55155-4194

Compliance Inspection Form

Existing Subsurface Sewage Treatment Systems (SSTS)

ON-SITE SEPTIC SYSTEM CONDITION REPORT

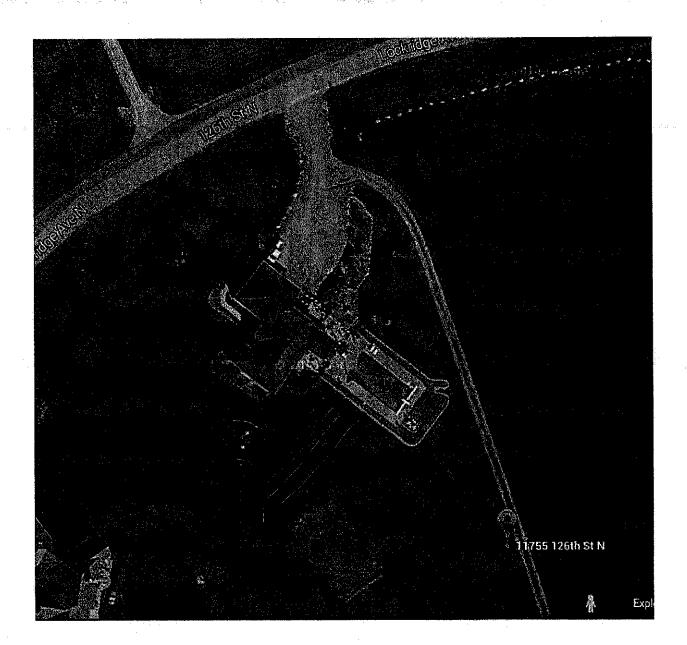
Jeffrey A. Fertig Inspector/Owner Soil Boring Log

→	@3	1.0						_
Depth of System or			hes		1	Flood Plain	: Yes	(No)
Depth to Restrictive	Layer >4	inc	hes	1		Shoreland	: Yes	No
Type of Observation	a: Probe	Pit	Boring	Well Hea	ad Protect	tion area:	Yes	NO
General Soil Textur	e: Sand	Loam	Clay				2 - 20	٣
Draina		Problen			/

- A TELLER	g c. 000a	Tigoton	us.	Well Info	: I	ocation	Fron	k
						Depth	>50	•
	Site Dray	ving			Depth	Texture	Color	Structure
					0-8"	fine Sund	104K	Blocky Platy Prismatic
	ge A	Hacl	led		8-24"	Sendy Clay Loam	104R 414	Blocky Platy Prismatic
5	'sl	. \$.			24-66	SIND	7.54ª 5/4	Błocky Platy Prismatic
							·	Blocky
								Platy Prismatic
				<u> </u>	to de	Additiona	al Notes:	ATISHALIA
						,		
Inspection Perform	ned by:	Sunrise Se	ptic Service	<u>s</u> 444	Registrat	ilon Number		299
Site Address Legal Description	North Star Ban 1755 126TH S CELLER FARM 32.031.20.24.0	T N, Stillwa			<u>_</u> .	· · · · · · · · · · · · · · · · · · ·	· · · · · · · · · · · · · · · · · · ·	······································
