Compliance Inspection Form
Existing Subsurface Sewage Treatment Systems (SSTS)

Property address: 21860 Pomroy Ave N Scandia, MN 55073

Brief system description: (2) 1,000 gallon pre cast septic tanks, 1,000 gallon pre cast lift station, mound dispersal system

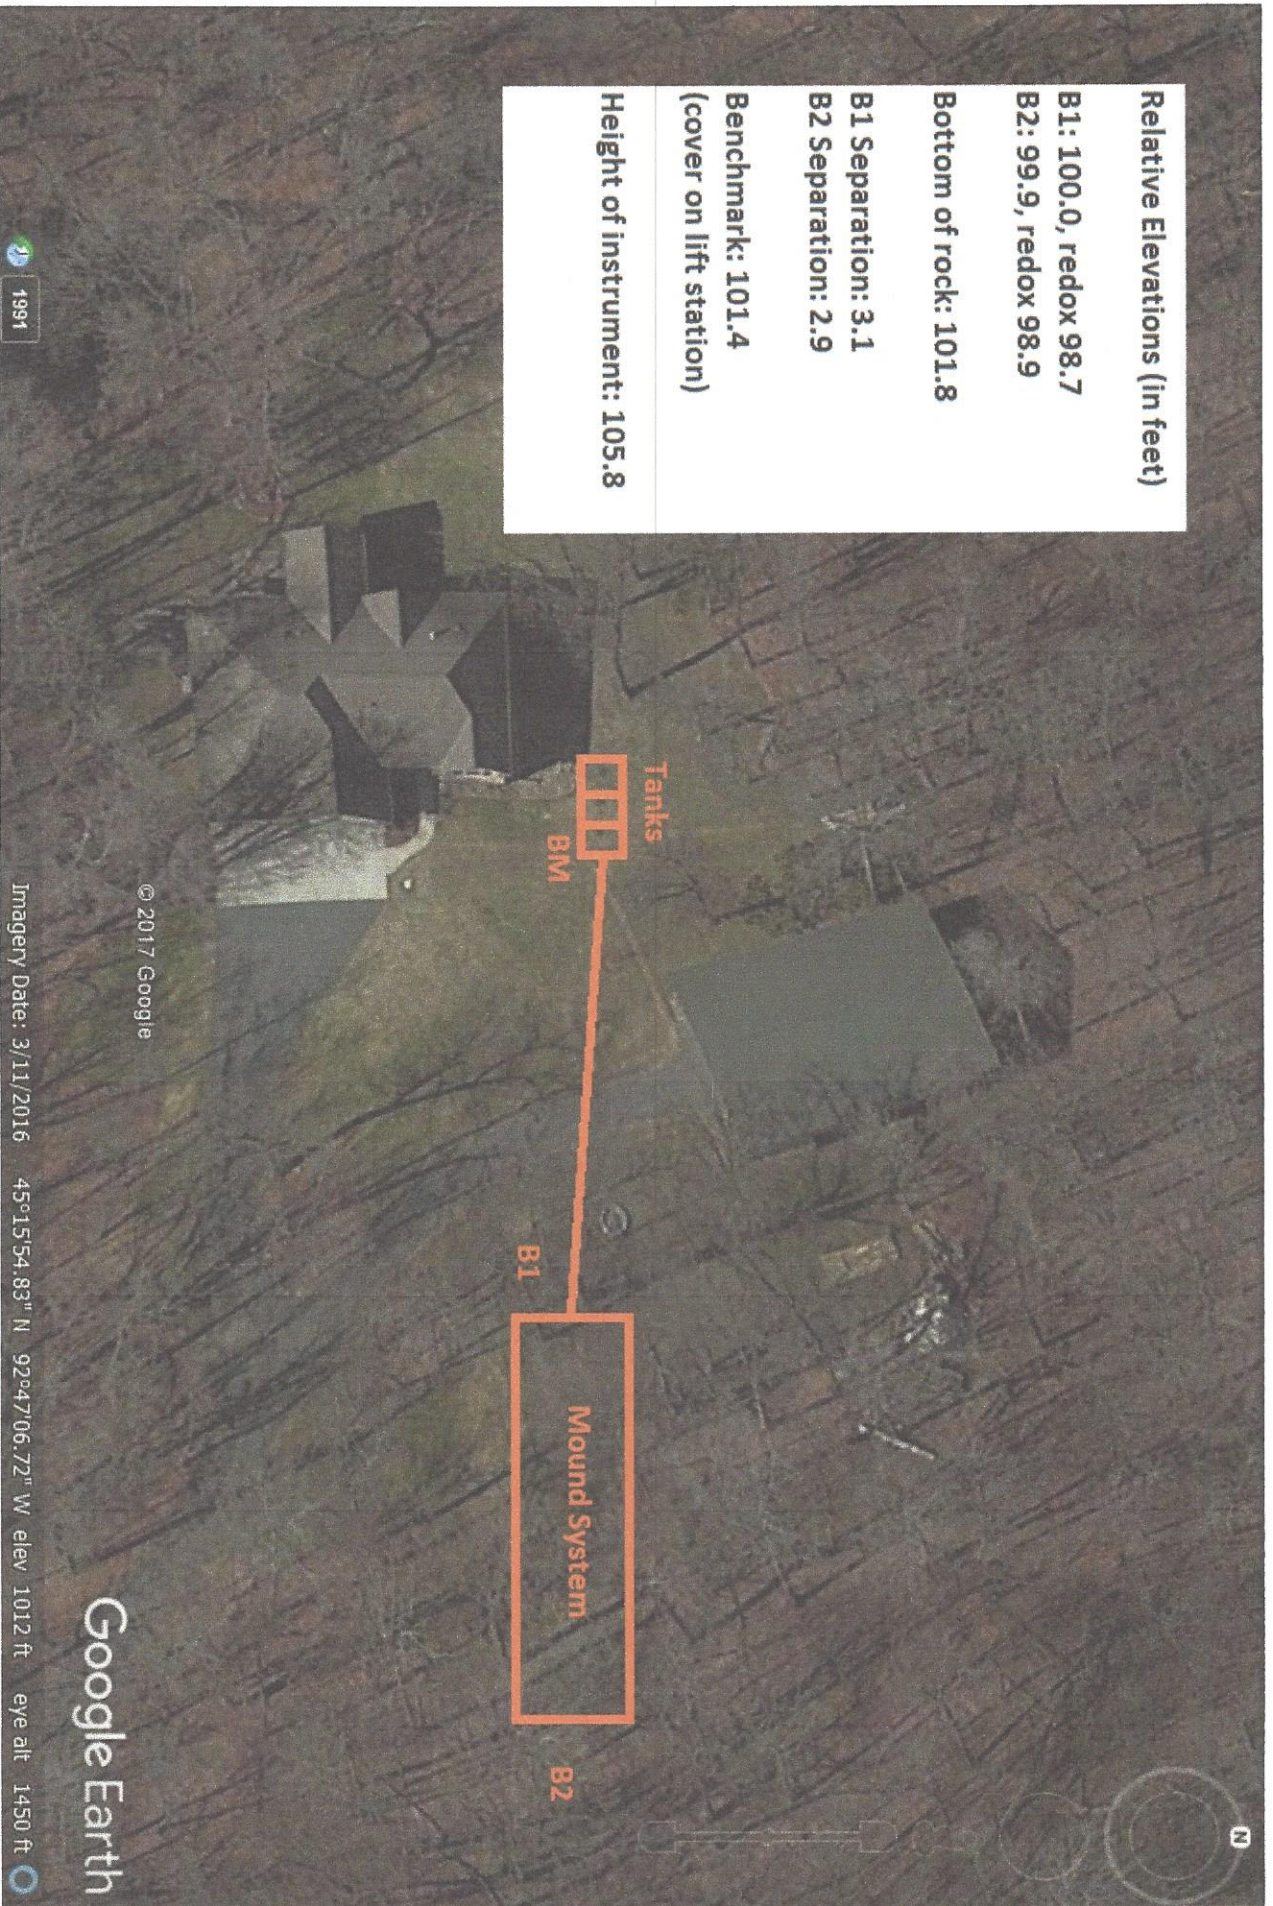
Relative Elevations (in feet)

B1: 100.0, redox 98.7

B2: 99.9, redox 98.9

Bottom of rock: 101.8

B1 Separation: 3.1

B2 Separation: 2.9

Benchmark: 101.4

(cover on lift station)

Height of instrument: 105.8
